Earthquake Reconnaissance: Guatemala, February 1976

D.H. Weichert
Division of Seismology & Geothermal Studies
Earth Physics Branch
Department of Energy, Mines & Resources
Ottawa, Ontario K1A 0Y3

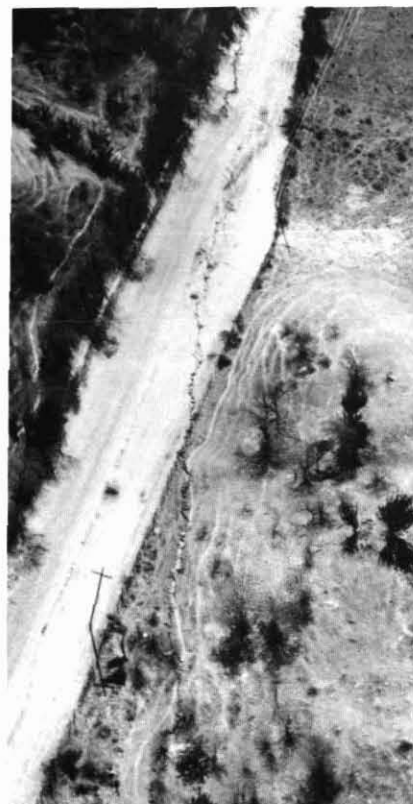
The closest approach of the fault rupture to Guatemala City was about 25 km due north. The main crack zone of deformed ground varied in width from about 2 m to 5 m, but occasionally appeared as wide as 9 m. Several slip measurements were made by USGS and EERI geologists, ranging from a minimum 0.4 m in the epicentral area to a maximum of 1.4 m directly north of Guatemala City. This increase of offset from the epicentral area towards the west appeared to be confirmed by other intermediate measurements. It is also consistent with seismograms recorded in Canada, which show a gradual build-up of amplitude over the first 50 to 70 seconds, corresponding to the time of propagation of the fault break. No vertical component of slip was observed for the main fault. Some secondary faulting was reported from about the centre of the main fault, paralleling it about 0.5 km to the south. Like the main fault, it appears as a series of right-stepping en echelon cracks, extending for about 3 km. Secondary faulting was

Figure 3
Faultbreak, easily visible as it crosses a dirt road, note the right-stepping en echelon pattern, which was generally observed.

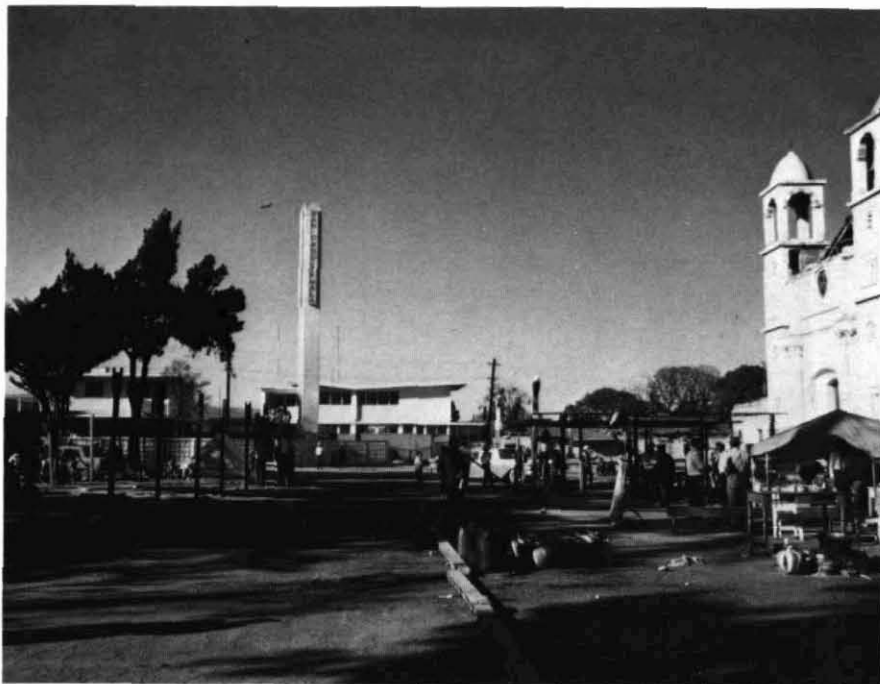
Figure 6
Chimaltenango: modern bank building and decorative brick wall remained standing.

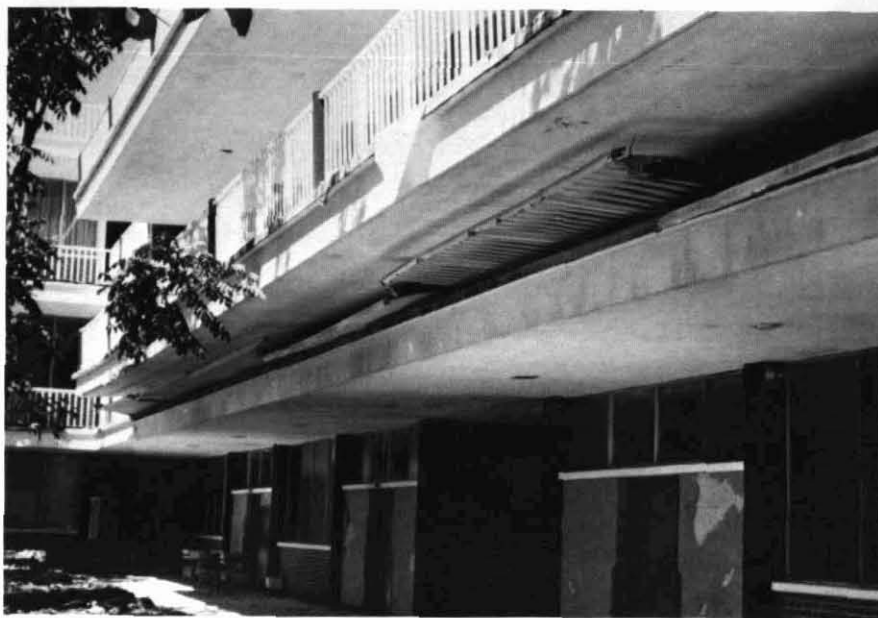
Complete collapse of heavy concrete canopies supported by rather fragile looking reinforced concrete columns was widespread, but not surprising. Collapses of engineered buildings were rare and usually attributable to doubtful design. Figure 7 shows a view of a collapsed second story of a school: it contained no shear walls. Collapse of some columns caused the Terminal Hotel to break in half. At the Camino Real Hotel, an unusual architectural effect was achieved by a supporting X-type outside frame. Here, many of the eastern legs in the ground floor were shattered

Figure 7
Collapsed second floor of a school in southeast Guatemala City, about 30 km from fault.
