Active Earth: Rain-induced Landslides in the Canadian Cordillera, July 1988

S. G. Evans and J. J. Clague

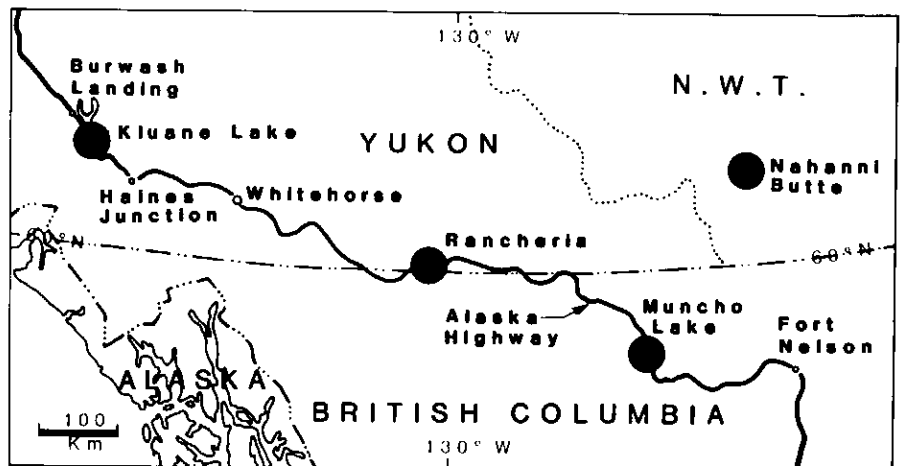
Figure 1 Location of areas of rainfall-triggered landslides (black circles) discussed in text.

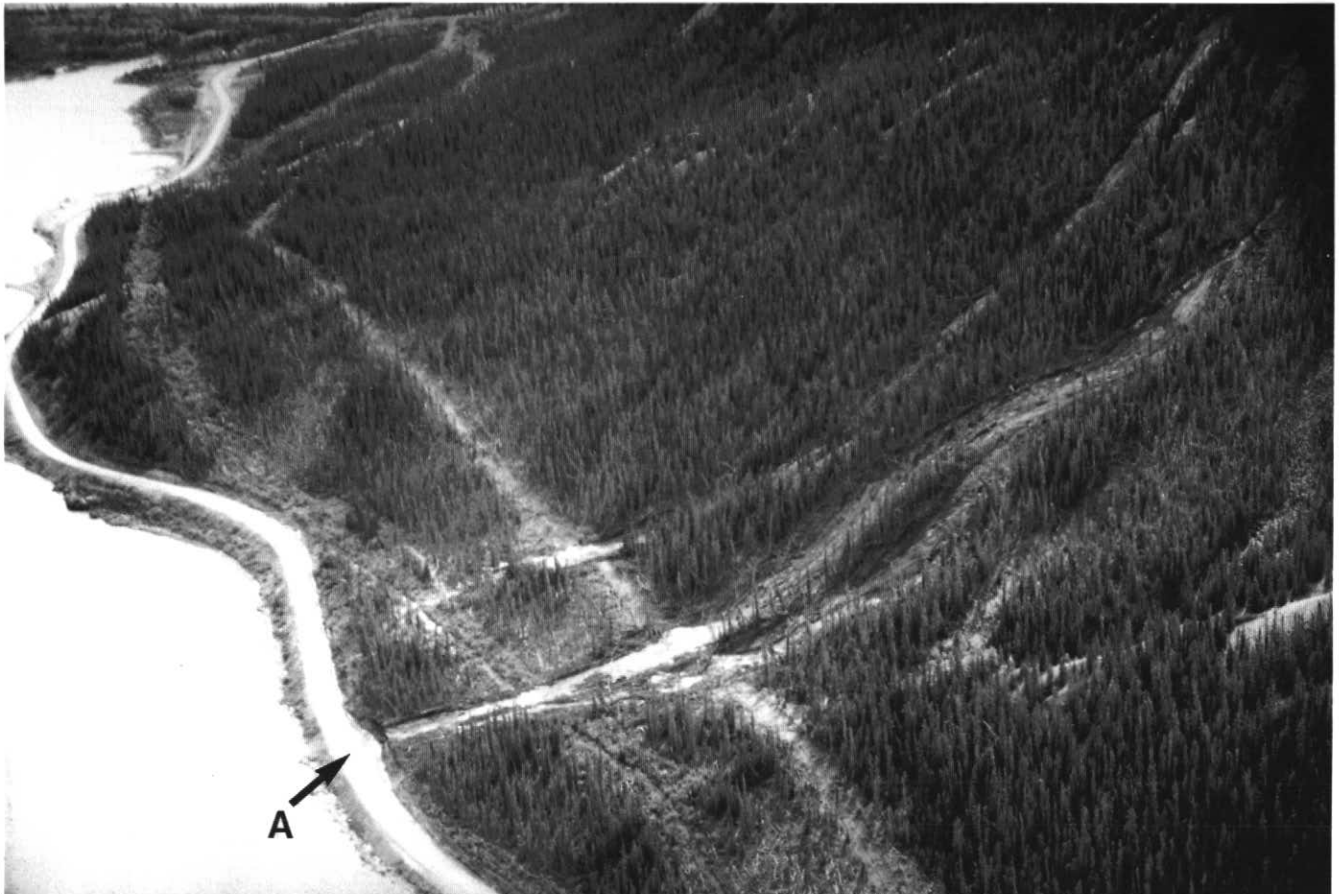
Figure 8 Oblique aerial photograph of two debris avalanches which occurred on open slopes above the Alaska Highway during the July rains. The Highway was blocked at A. Kluane Lake is seen on the left of the photograph.

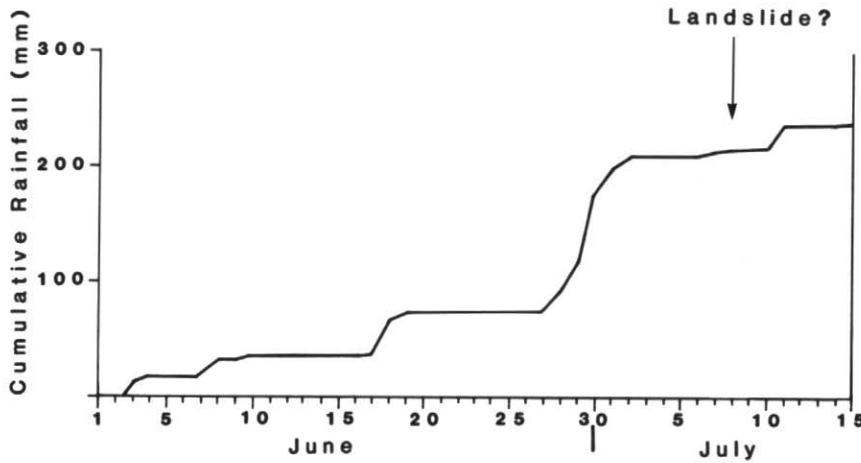
Figure 12 Cumulative rainfall at Nahanni Butte, June 1-July 15, 1988.
