Geomorphic Effects of Flooding Along Reaches of Selected Rivers in the Saguenay Region, Québec, July 1996

G. R. Brooks and D. E. Lawrence

Volume 54, Number 3, 2000

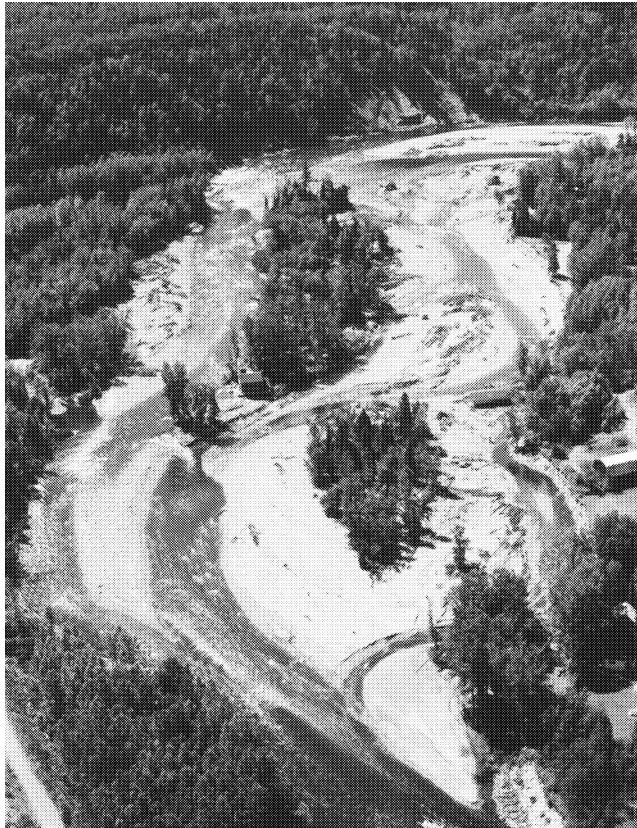
FIGURE 8. Oblique photograph of the post-flood channel of the Rivière à Mars looking upstream of km 8. Note, the multi-channelled character of the river and the broad width of the "flood" channel relative to that of the post-flood flow. Photograph taken July 29, 1996.
