**Geomorphological and vegetation interaction and its relationship to slope stability on the Niagara Escarpment, Bruce Peninsula, Ontario**

Michael R. Moss et William G. Nickling

Moss, M. R. & Nickling, W. G. (1980). Geomorphological and vegetation interaction and its relationship to slope stability on the Niagara Escarpment, Bruce Peninsula, Ontario. *Géographie physique et Quaternaire*, 34(1), 95-106. <https://doi.org/10.7202/1000386ar>

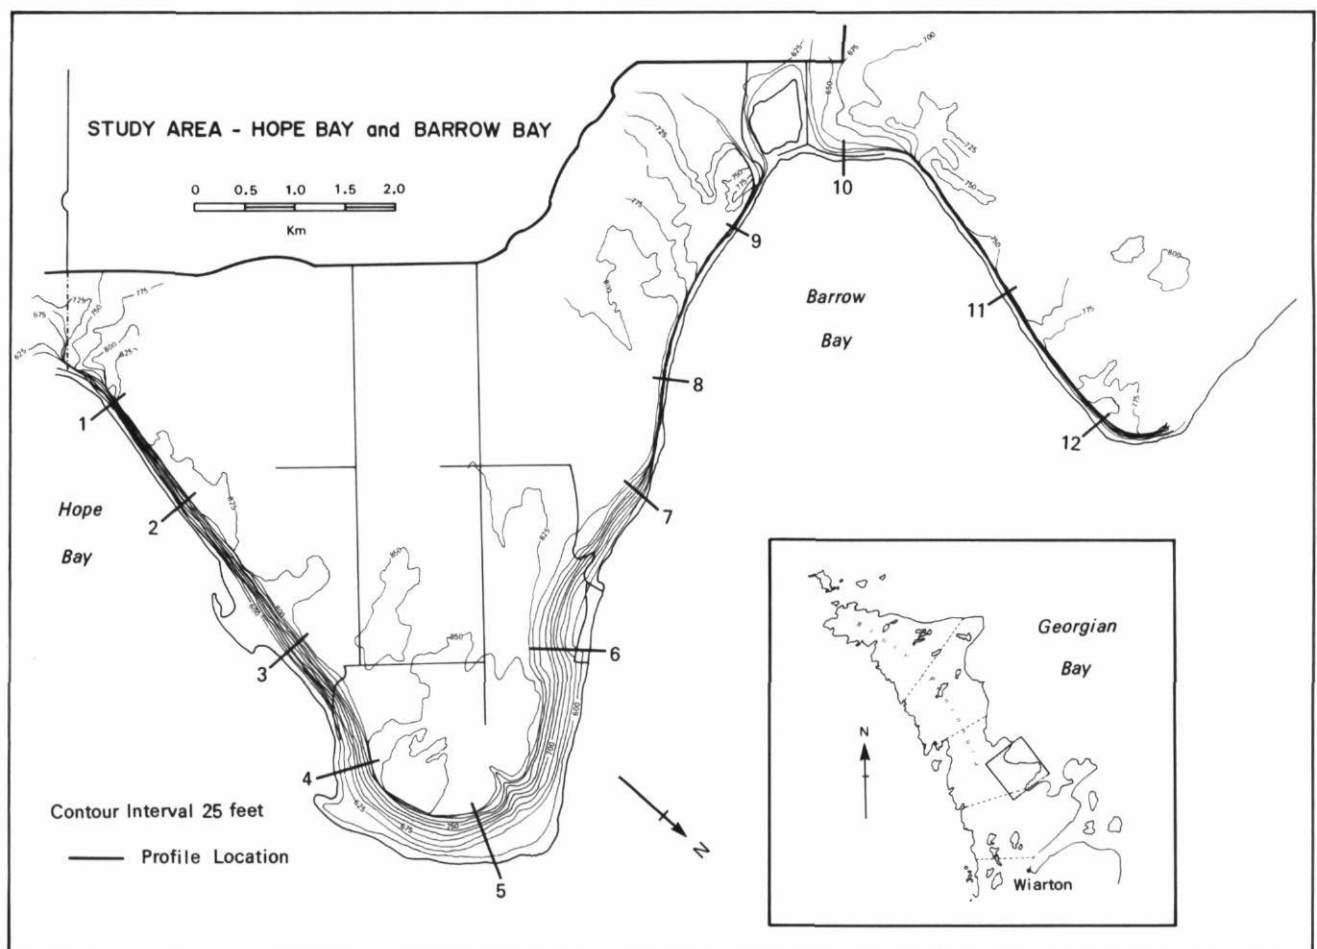
FIGURE 1. Hope and Barrow Bay study area (location inset). *Carte de localisation de la région à l'étude.*

To obtain the general understanding a series of 12 profiles were surveyed perpendicularly from the shoreline to points approximately 5 m back from the crest of the Escarpment. Profiles were derived from distance measurements taken by tape between each break of slope. The angle of each of these slope sections was measured in every case using an Abney level. No attempt was made to interpret the lithological characteristics of surface material at this stage but a simple measure of vegetation cover was made by noting the numbers of individuals of each species that covered the transect lines. Note was also taken of the depth and amount of soil cover. The location of the twelve profiles is indicated in Figure 1.

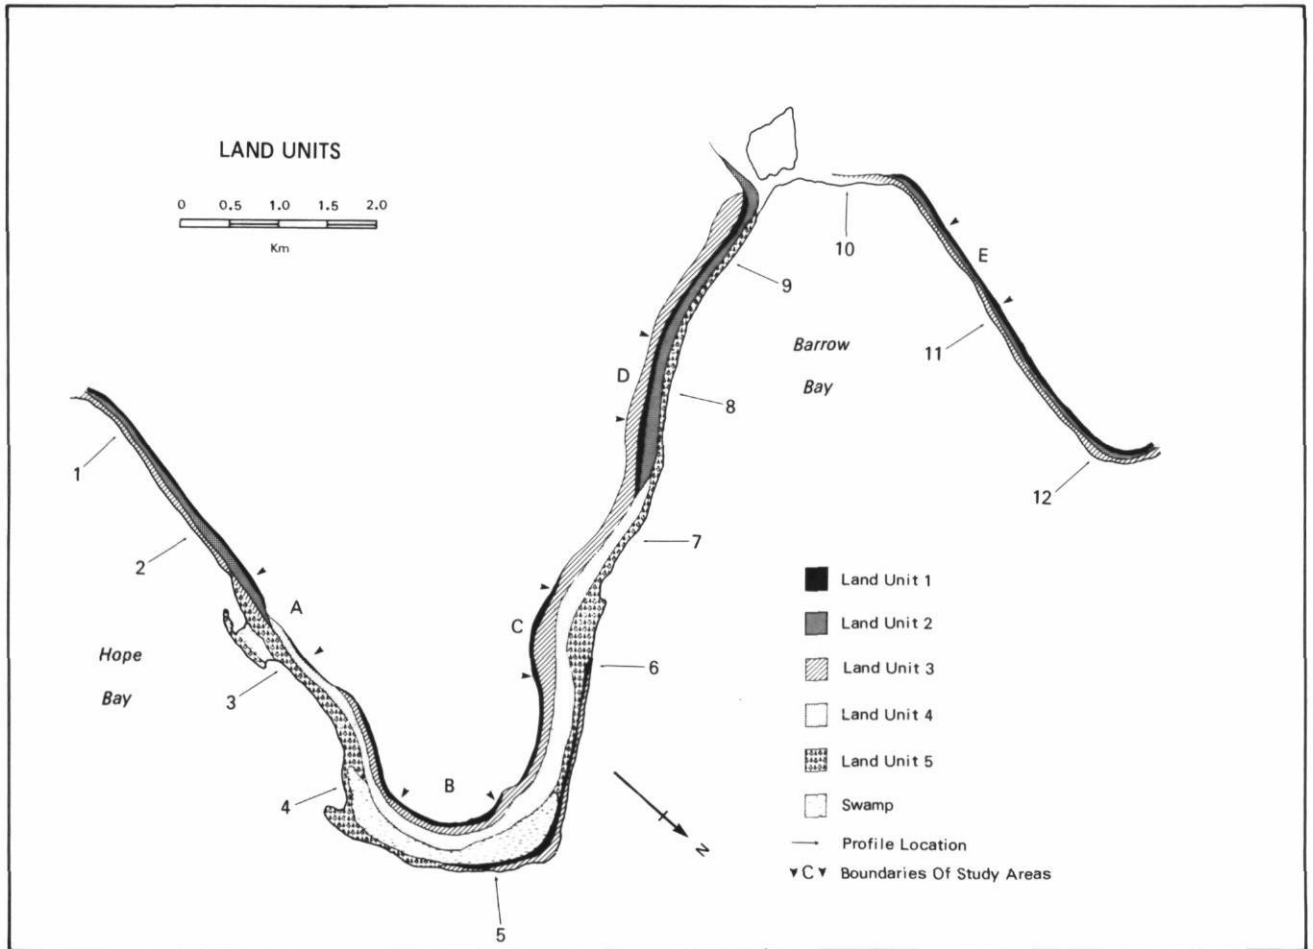
FIGURE 2. Land units in the Hope and Barrow Bay area. For characteristics of the individual units see Table II.

Les différentes unités de terrain dans la région à l'étude. Les caractéristiques de chacune des unités sont données dans le tableau II.

By using the basic profile data in conjunction with two recent sets of air photographs for the study area (1971 and 1976), it was possible to obtain a more comprehensive picture of the land surface as a whole. For convenience this information can be organized into a series of land units. Each of the land units recognized has, therefore, the common attributes of a limited range of slope angle, topography, soil development, and dominant vegetation. At the scale used the more individual features such as talus cones, debris slides, etc., were not included. The distribution of these land units is shown in Figure 2 and the details summarized in Table II.

Land Unit	Slope	Dominant Vegetation	Soil Development
1	>45°	<i>Thuja occidentalis</i> or no vegetation cover	(none)
2	20-45°	<i>Thuja occidentalis</i> with occasional <i>Betula papyrifera</i>	insignificant
3	<20°	<i>Betula papyrifera</i> with occasional <i>Thuja occidentalis</i> , <i>Acer saccharum</i> , <i>Fraxinus americana</i>	<5 cm intermittent
4	>20°	<i>Acer saccharum</i> , <i>Fraxinus americana</i> , <i>Ulmus americana</i>	5-10 cm intermittent
5	<20°	<i>Betula lutea</i> , <i>Acer</i> spp. dominant with occasional <i>Betula papyrifera</i> , and <i>Thuja occidentalis</i>	5-10 cm intermittent

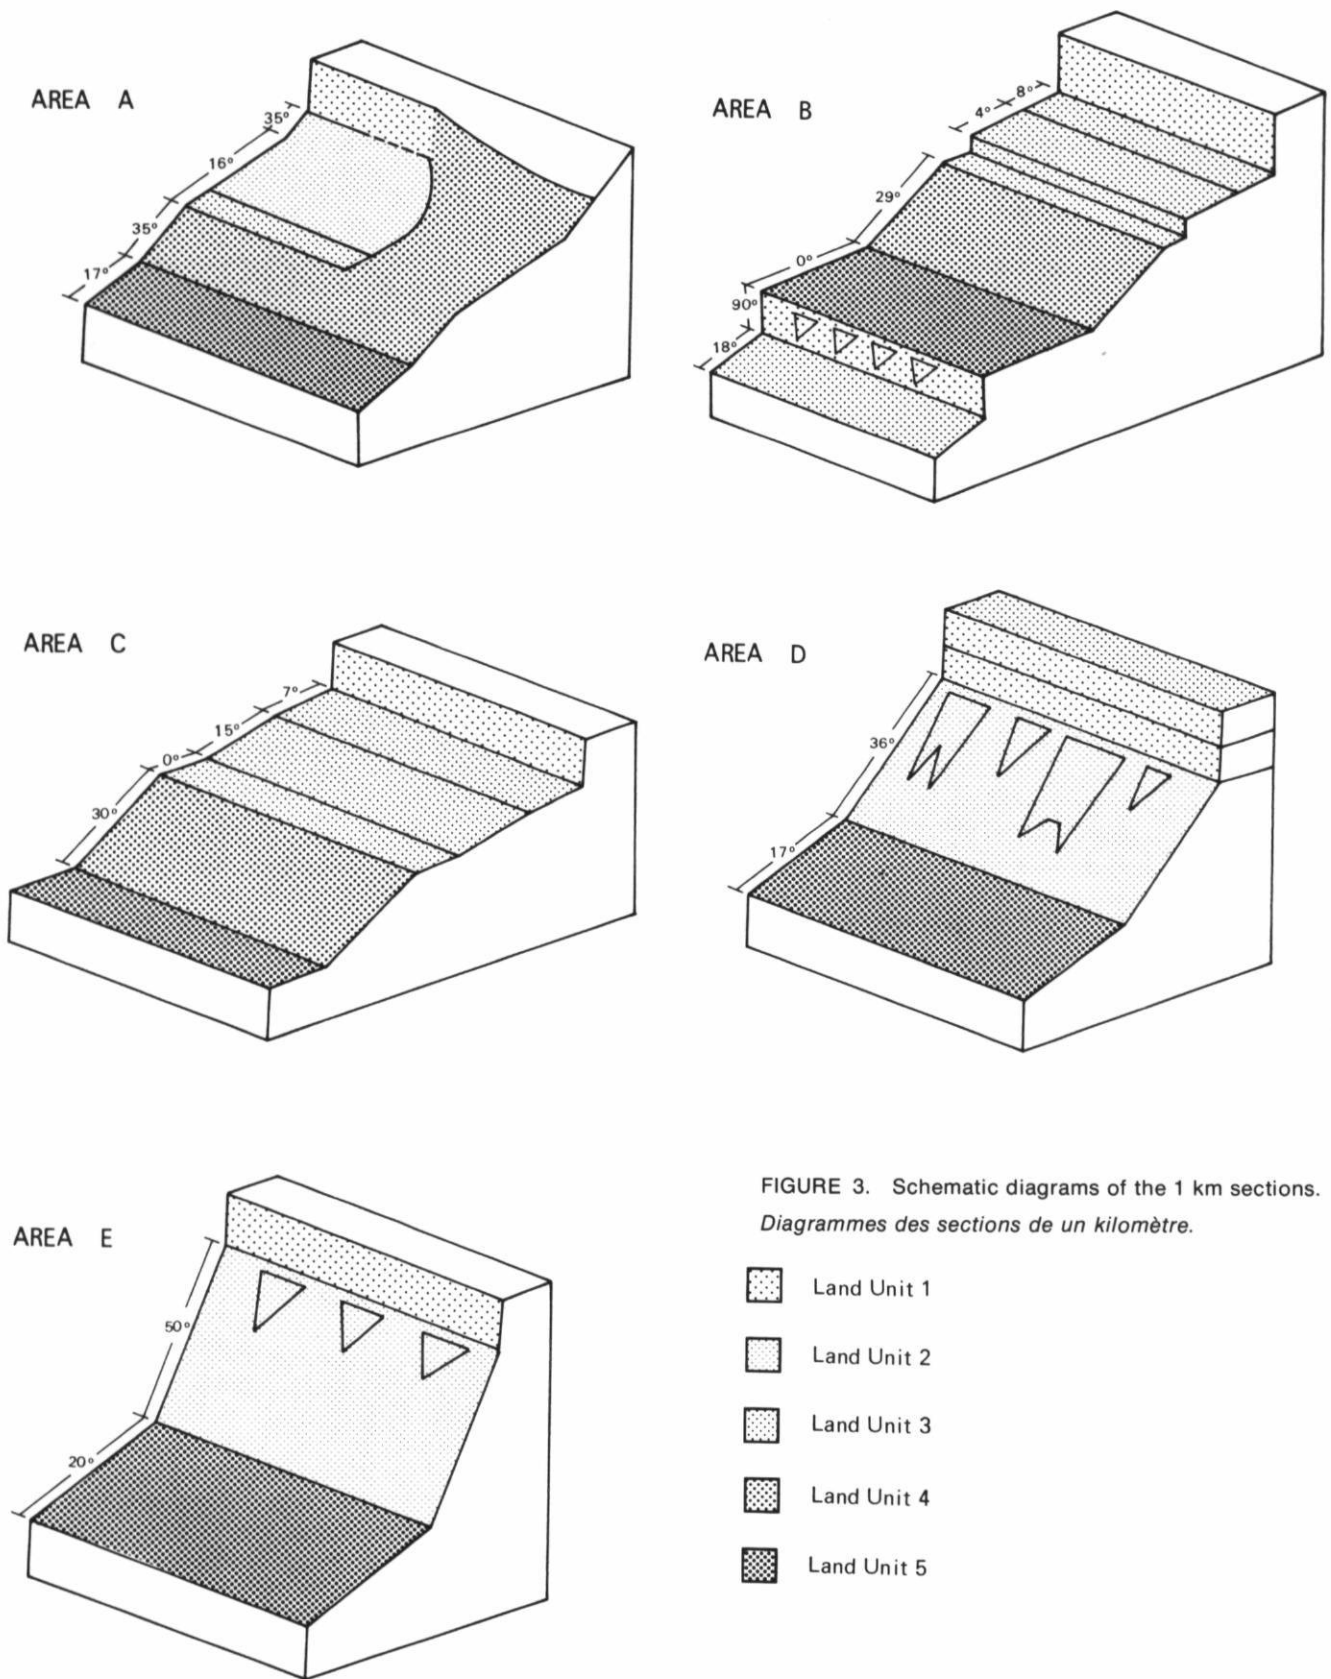
identified. The relative degree of *in situ* weathering of surficial rock debris and soil depth were also recorded. The surface form of each of these 1 km sections is shown in Figure 3.

At the second level of more detailed data collection five individual sections of the area were selected (A to E on Fig. 2 and Fig. 3). These were chosen to represent a range of conditions reflecting slope, aspect and lithology. Each section extended for 1 km in length along the Escarpment and data were collected from the scarp crest down to the shoreline. In each section the
