## Building Stones of Canada's Federal Parliament Buildings

D. E. Lawrence

Lawrence, D. E. (2001). Building Stones of Canada's Federal Parliament Buildings. *Geoscience Canada*, 28(1), 13–30.

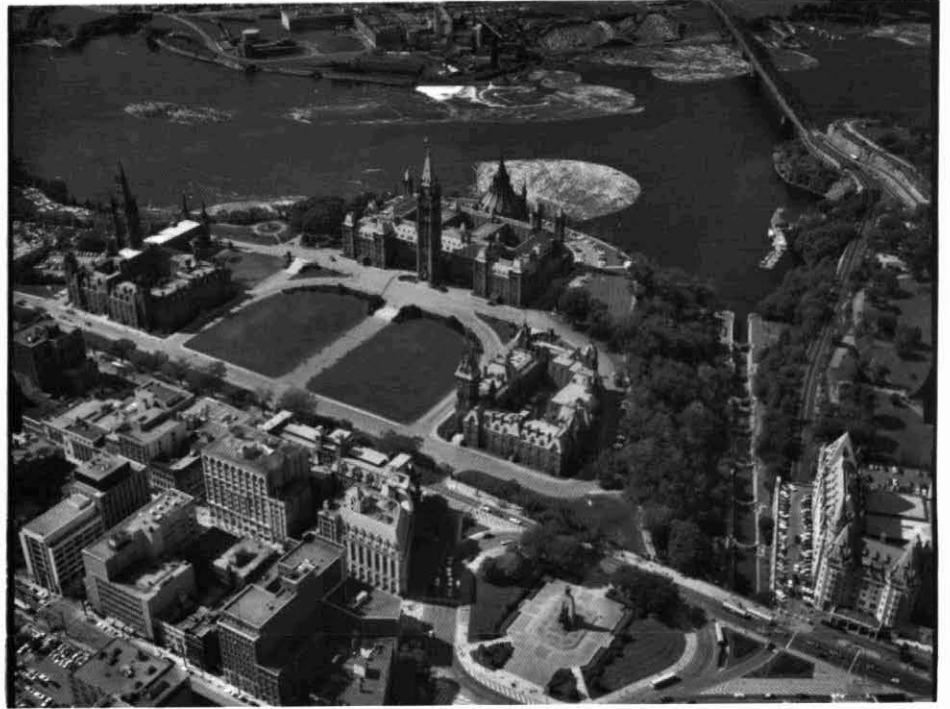
**Figure 1** Aerial view of Parliament Hill looking northwest, summer, 1974. The Rideau Canal and locks, completed in 1832, lie immediately to the east; the Chateau Laurier Hotel is seen at lower right on the east bank of the Canal; the Ottawa River is seen to the north. National Air Photo Library, Natural Resources Canada.

Canada's Parliament Buildings are located on an 11.6 ha site near the edge of a 50 m limestone cliff commanding a view over the Ottawa River to the north, and the Rideau Canal to the east (Fig. 1). In 1977 Parliament Hill and all of its buildings were designated as a National Historic Site.

The Parliament Buildings comprise three main "blocks": the south-facing Centre Block with its attached Peace Tower in front and Library at the back (Fig. 1), flanked on either side by East and West blocks. All three face inward to form three sides of a large quadrangle. The eternal flame, built in 1967 to commemorate Canada's confederation, is located on the south side of the quadrangle. The East and West blocks, built between 1859 and 1865, are original structures, as is the Library. The Centre Block and the Peace Tower were reconstructed after the original Centre Block and Victoria Tower, built 1859-1878 (Fig. 2), were burned beyond saving on 3 February 1916 (Fig. 3).

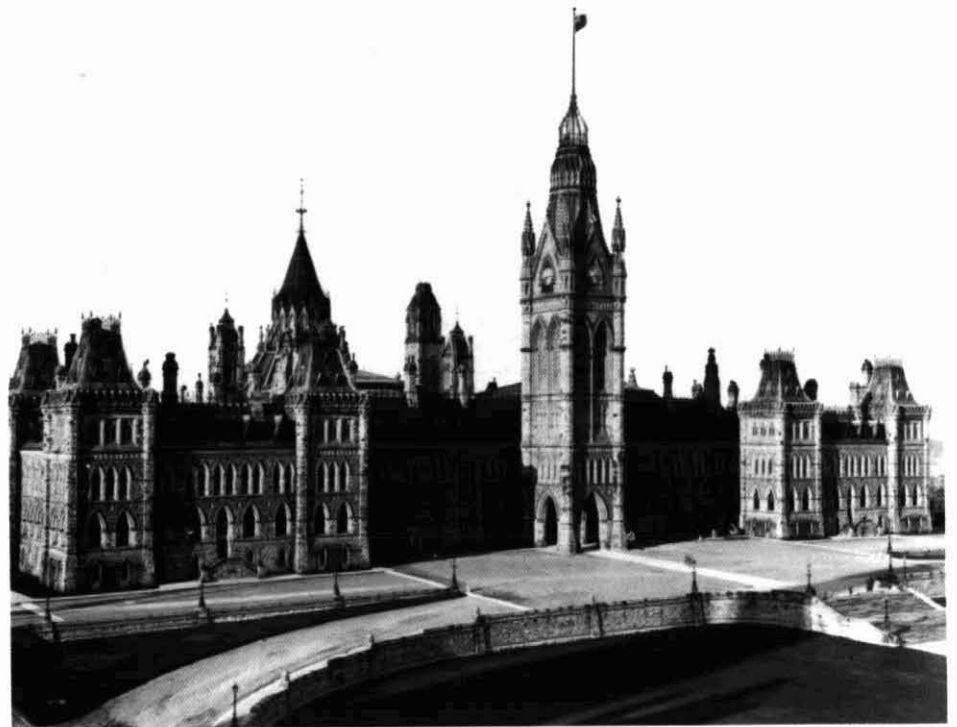
**Figure 2** The original Centre Block and Victoria Tower, built between 1859 and 1866, were destroyed by fire on 3 February 1916. Photo circa 1885, National Archives of Canada PA 178205.

The original 1859 structure (Fig. 2) required the careful choice of building stone, not only of appropriate colour and texture, but also with engineering attributes of strength and durability. It also had to be quarried, cut, and transported at reasonable cost!

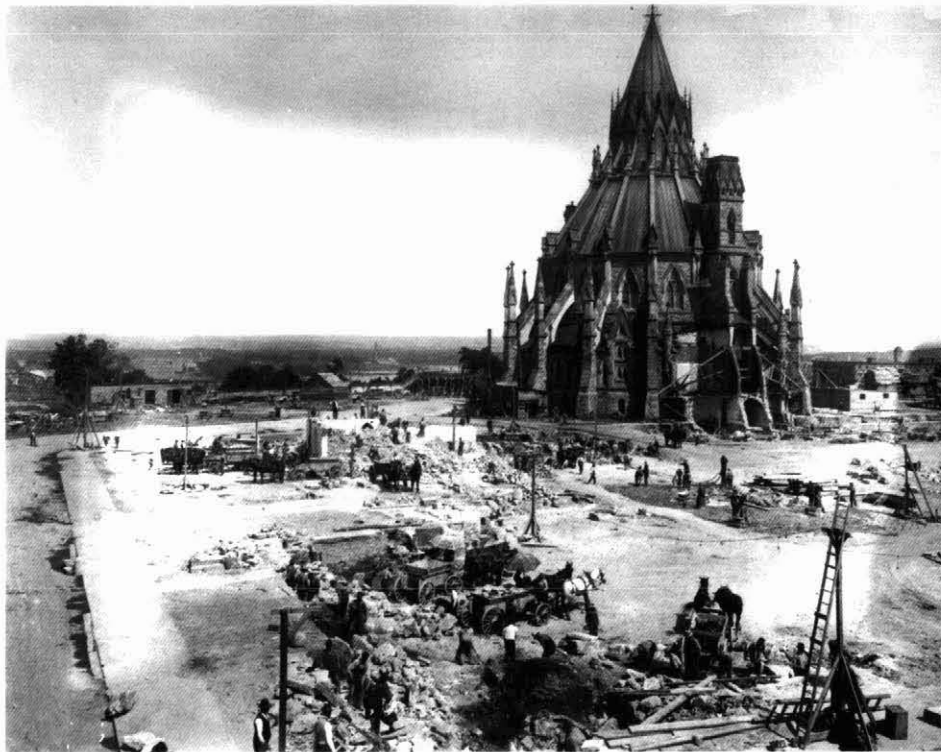
**Figure 3** Preparation of Parliament Hill for reconstruction of the Centre Block, 15 August 1916. Workmen with horse teams are removing the last of the rubble from the foundations of the former building. In the middle ground, in front of the Library, another crew is drilling blast holes for foundation excavations. Only the Parliamentary Library remains intact. Its shored up entrance, which connected it to the Centre Block, can be seen beyond the drilling crew. National Archives of Canada PA130624.

The reconstructed Centre Block had its beginnings with the destruction of the original building. The February 1916 fire started in the Parliamentary Reading Room, ravaged the Centre Block and Victoria Tower, and killed 7 people. Only the Library was spared (Fig. 3). At first it was thought that the facade of the original Centre Building could be saved; however, following investigation of the walls and foundations, it was deemed that this would be imprudent and unsafe. The reconstruction for the Centre Block began almost immediately, and by the fall of 1916 was well underway (Fig. 4).

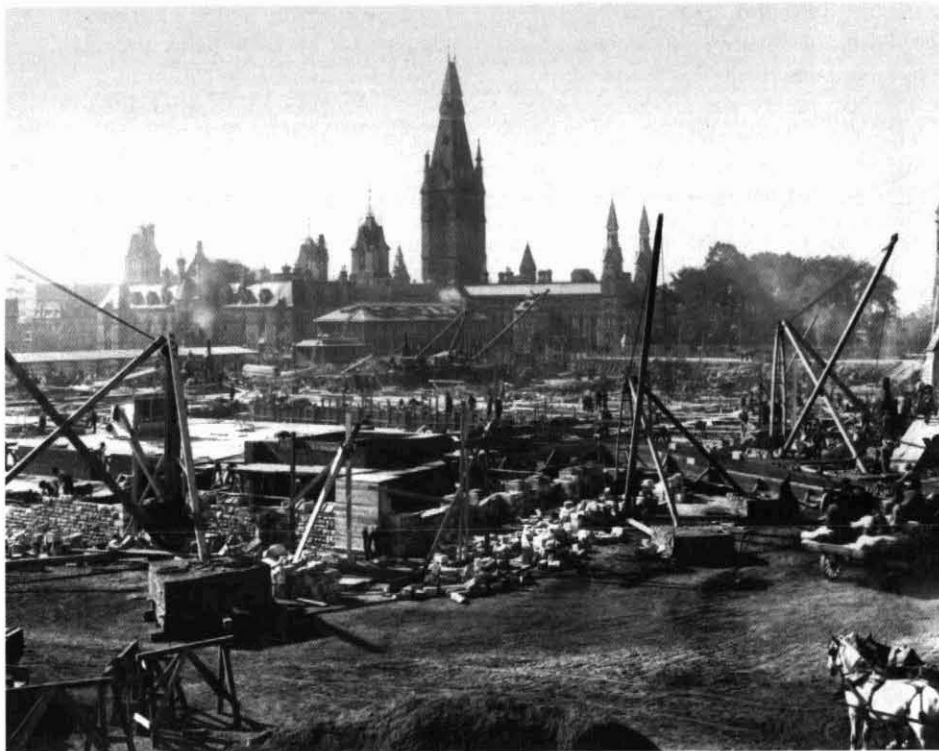
**Figure 4** View looking southwest showing the early stages of the reconstruction of the Centre Block. Beyond the construction on the left is the stone cutting shed and to the right the architect's offices. The West Block is in the background. Photo taken 26 September 1916. National Archives of Canada C6361.

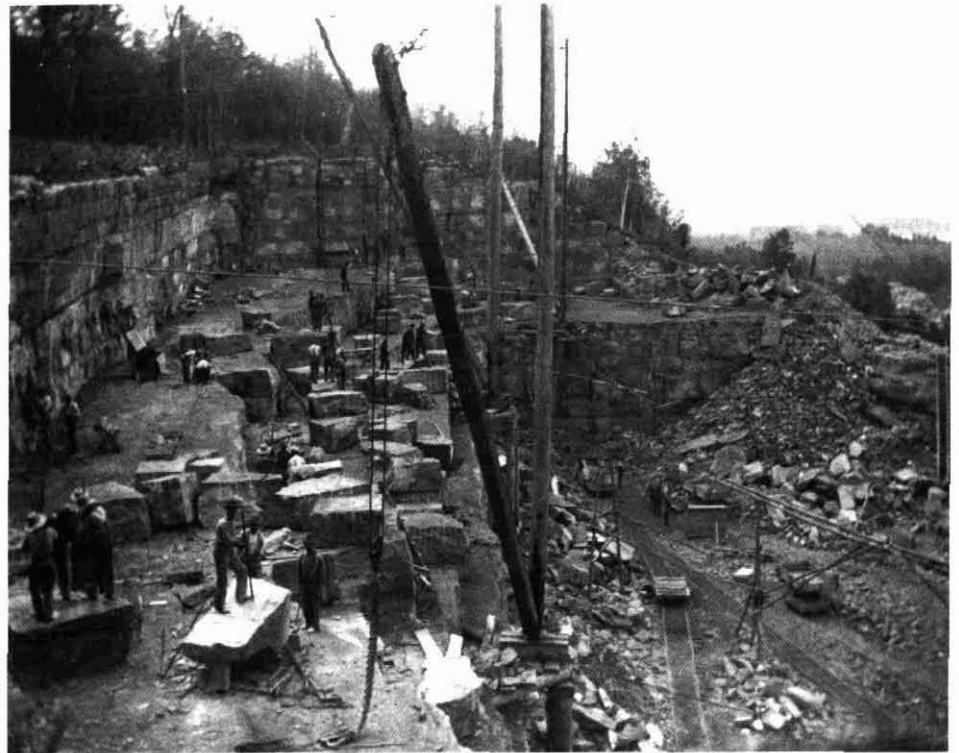
Figure 6 Quarrying operations in the early 1900s in the Ottawa Valley were similar to those seen here at the Stewart Quarry, Rockland, Ontario, 1898. GSC collection, National Archives of Canada, PA51315.

Dick Williams, a Welshman who came to Canada in 1902, opened a small quarry in the Nepean formation on the farm of his father-in-law (Fig. 6). The two began making paving stones in 1912 and in 1916 they were joined by a young Scot, Archie Campbell, a recently apprenticed quarryman (Jennie Hutchinson, daughter of Dick Williams, personal communication, July 2000).

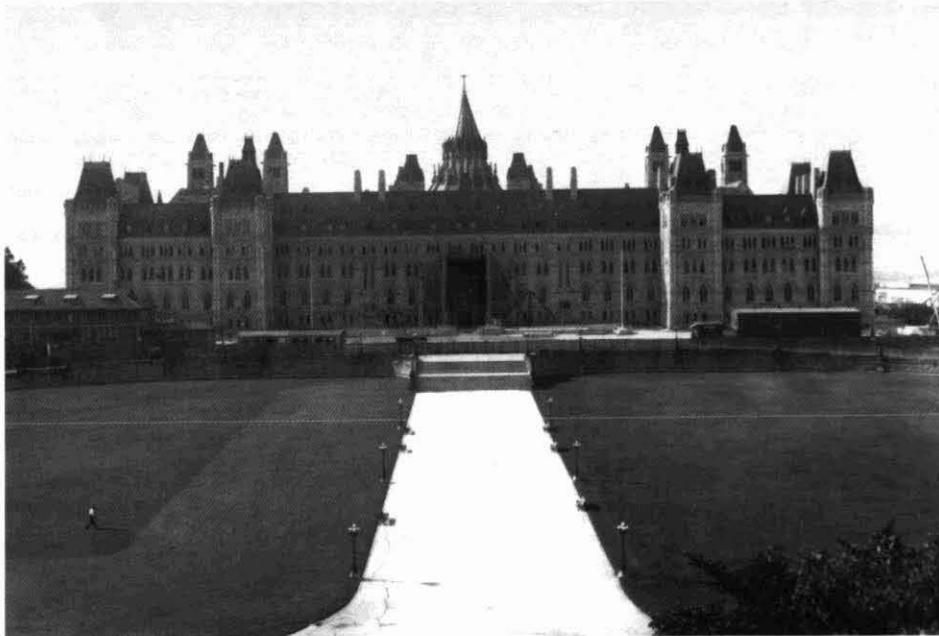
**Figure 12** The nearly completed Centre Block, in 1919. Construction of the Peace Tower had not been started at this time. The stone masons' shed and the architect's site office can be seen on the left in front of the building. W.J. Topley, National Archives of Canada PA 12925.

The unfinished Centre Block was officially opened on 26 February 1920 (Fig. 12).

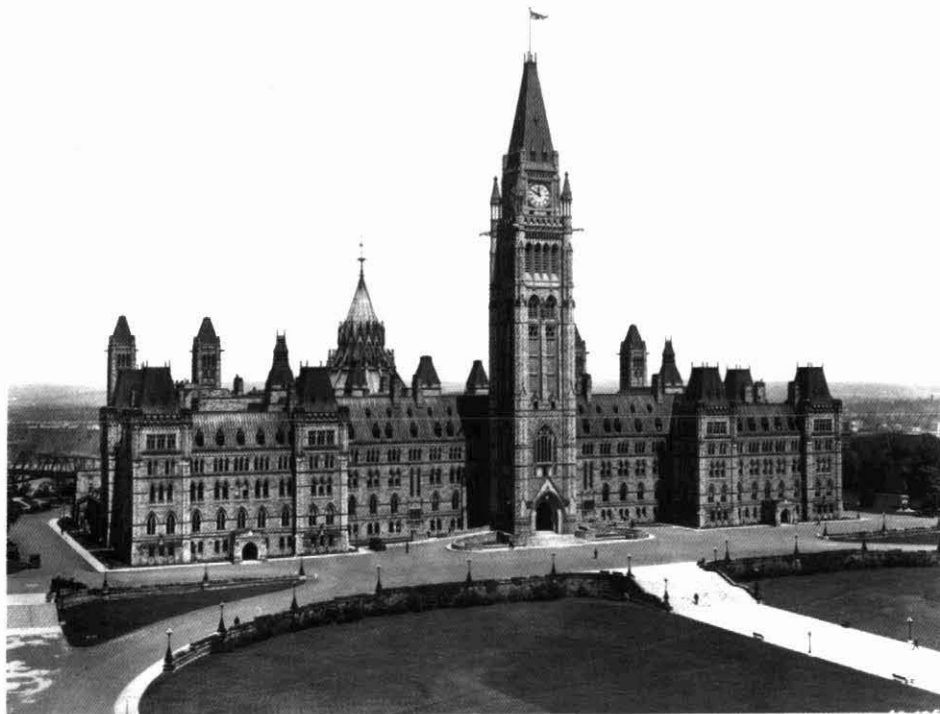
Figure 14 Canada's completed reconstructed Centre Block, circa 1953. Photo taken from the West Block. National Archives of Canada, C5856.

The Centre Block and the Peace Tower were finally completed after 12 turbulent years (Fig. 14). As noted by Gowans (Gowans, *in* Marsh, 1999, p. 1763), these buildings, along with the earlier East and West blocks, present one of Canada's most visually striking and historically remarkable building complexes.
