# Geology of the Parliament Buildings 5: Geology of the Manitoba Legislative Building

W. C. Brisbin, Graham Young and Jeff Young

Volume 32, Number 4, December 2005

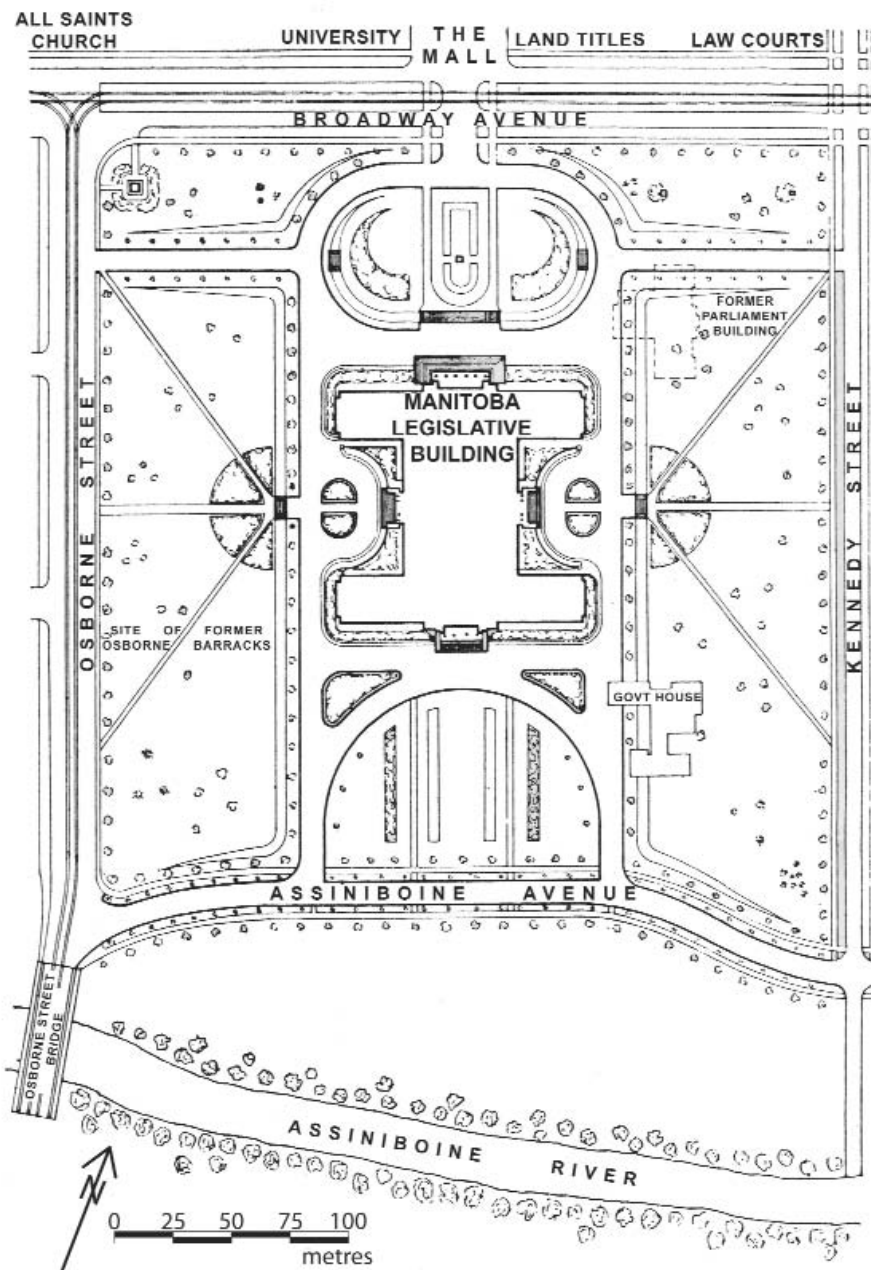
**Figure 1.** Plan of the Manitoba Legislative Building and the surrounding area. Modified from Leslie (1925).

Bridge (Fig. 1). The building is neoclassical, incorporating Greek, Roman and Egyptian motifs and elements. Bodnar (1979, p.136) described it as “exhibiting a graceful simplified quality, Beaux-Arts in its arrangement of masses and spaces, but more complex in its treatment of plan and dome.” The plan of the building is in the form of an H. The mass of the building is supported by concrete caissons that extend to indurated till or bedrock. Structural brick piers faced with dimension stone comprise the exterior walls, and structural brick piers faced with dimension stone or plaster, are used for the interior walls. Floors are concrete, covered by dimension stone or terrazzo.

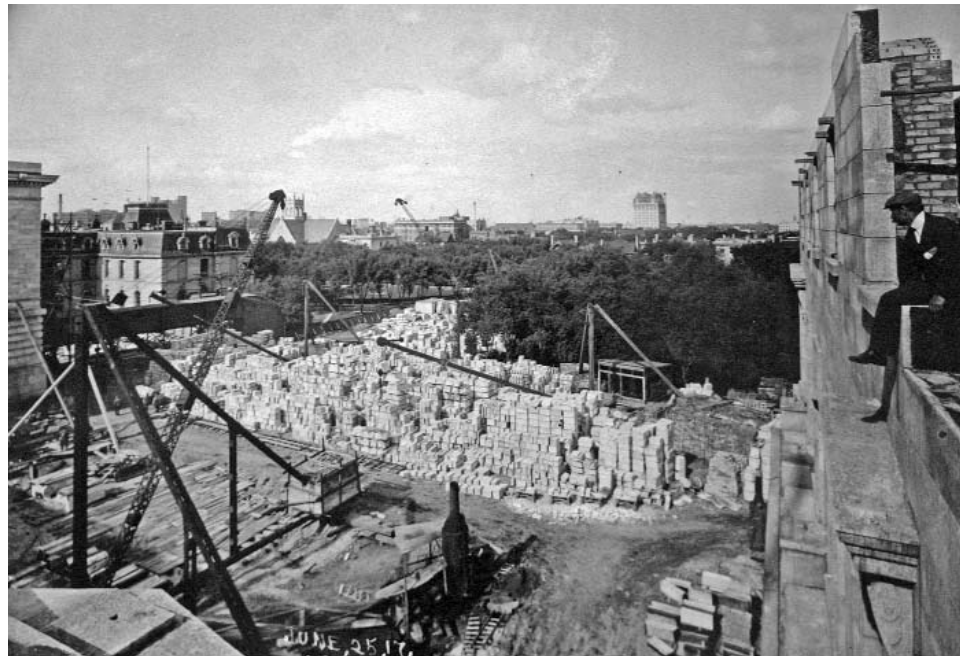
**Figure 2.** June 1917; an observer on the SE wing of the Legislative Building overlooks the east grounds of the building site (AM, Foote Collection 82). A brick bearing wall with Tyndall Stone facing occurs behind the observer. Blocks of Tyndall Stone are stacked in a staging area below. The old Manitoba parliament building is located on the left side of the photograph adjacent to the NE wing. The Fort Garry Hotel is the tall building in the distance.

Construction began in 1913. The general contract for construction was awarded to Thomas Kelly and Sons in July 1913. In January 1915, after a delay caused by the start of World War I, a review revealed financial and contractual improprieties, and the Kelly contract was terminated. Furthermore, problems with defective caissons delayed construction. It was not until the end of 1916 that new tenders were called to complete the construction. The new general contractor was J. McDiarmid and Company. Figures 2 and 3 show the different stages of construction.

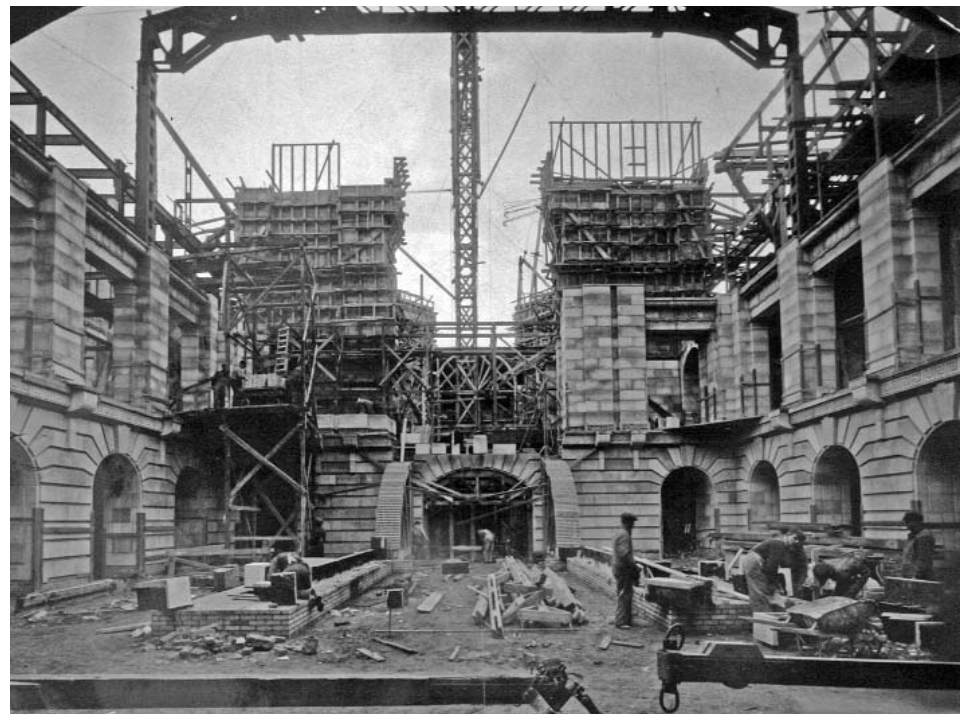
**Figure 3.** 1916; the grand staircase area on the main floor (AM, Foote Collection 78). Workers lay brick and steel supports to prepare the base of the grand staircase for its railings, addition of the Tyndall Stone facing and placement of the two bronze bison that flank the staircase ( see Figure 8a).

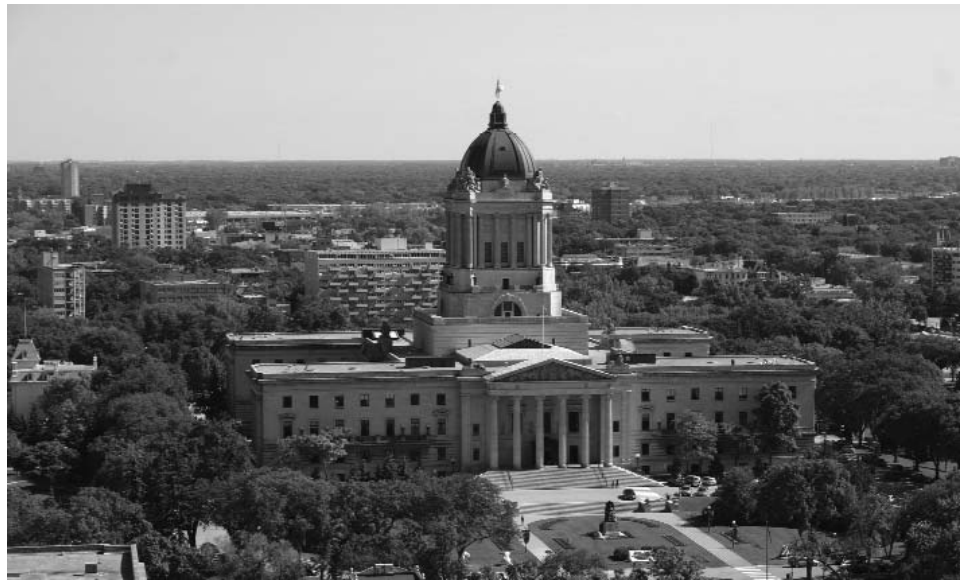
**Figure 4.** The Manitoba Legislative Building viewed from the north in spring 2005. Visitors are greeted at the front entrance by six ionic columns capped with a pediment symbolizing Canada. A sculpture of Queen Victoria, seen on the front lawn of the building, is one of many sculptures on the grounds. The refurbished Golden Boy atop the building symbolizes Manitoba's eternal youth and progress. Government House, the residence of the Lieutenant-Governor of Manitoba, is located on the left side of the photograph.

By February 1920, the new Legislative Building was completed. It was dedicated July 15, 1920, on the fiftieth Anniversary of the province. Figure 4 is a current view of the front of the building.

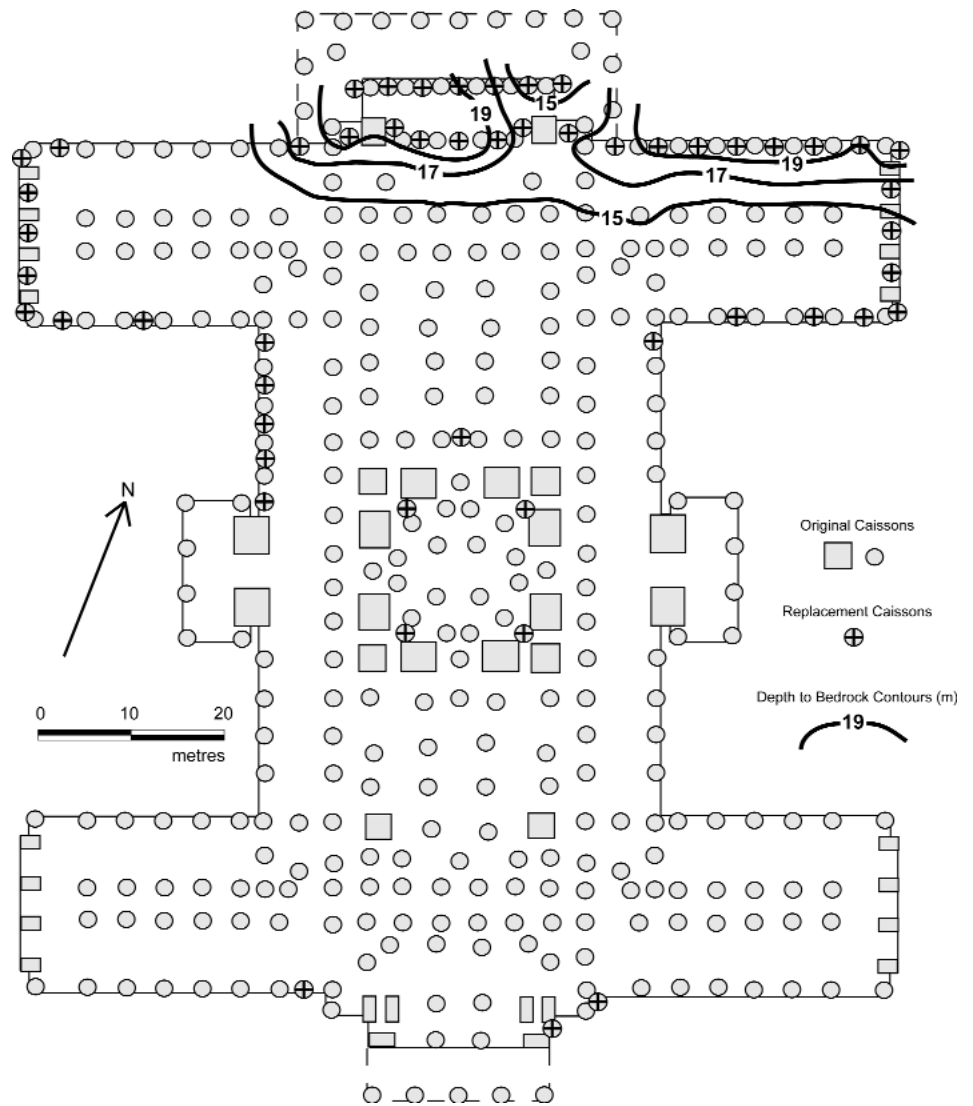
**Figure 5.** Plan and location of caissons, Manitoba Legislative Building (AM, GR3085 G8107, Item 545). The Legislative Building rests on 421 caissons, 369 of which are original caissons, and 52 of which replaced original caissons of poor quality. Caissons on this figure are to scale. The building is outlined by a thin solid line, except under the stairways at the north and south entrances, where the outline is dashed. The depth to the bedrock surface, measured from the top of the steel grillage that rests on the caissons, has been contoured using a contour interval of 2 m. Depth values under the southern part of the building are between 14 and 15 m; consequently no contours are shown. Beneath the north entrance, contour lines have not been extended under the stairways because the depths to bedrock are poorly constrained.

frame resting on the caissons (i.e., grillage), except under the north part of the building where it occurs at 14 to 20 m (Fig. 5). Bedrock relief in the northeast wing and under the north portico defines abrupt depressions that drop up to several metres (AM, GR 3085 G8106, Item 196, AM, GR 1609 G8014, File 3 Item 2). These depressions in the bedrock surface are consistent with paleokarst features underlying Winnipeg (Baracos and Kingerski, 1998).

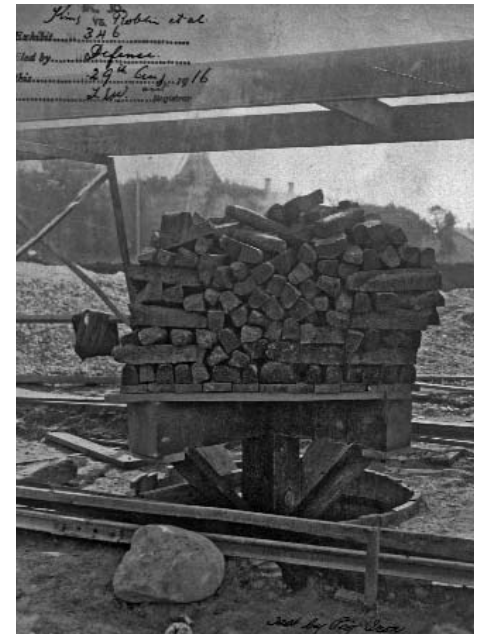
**Figure 6.** Loaded platform for the bearing test on indurated till in the excavation for caisson 39, located adjacent the north portico along the northeast wing (AM, GR3085 G8101, Item 28). The test was done using a progressively loaded platform, 1.68 m square, that was erected on a 3 x 3.6 m rectangular mast extending to indurated till (AM, GR3085 G8100, Item 6). An initial 5 tons of pig iron was placed on the mast and 22 mm of settlement occurred after 3.5 hours. Another 10 tons of pig iron were added at intervals over the next 24 hours. A total of 26 mm of settlement was measured during the 44 hours of the test. Upon removal of the load 6 mm of rebound was measured. Wood cribbing and metal rings support the wall of the caisson excavation.

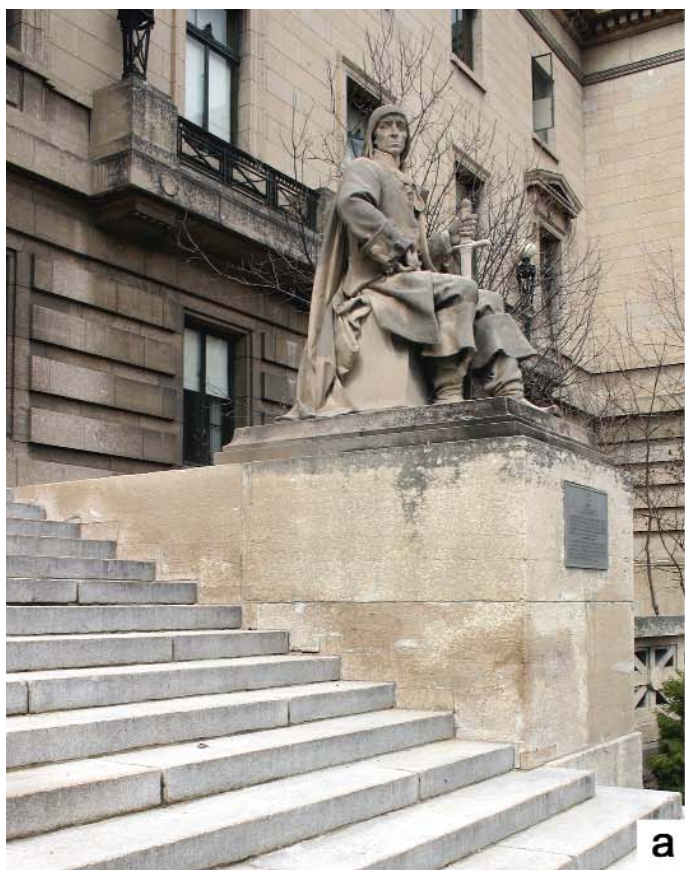
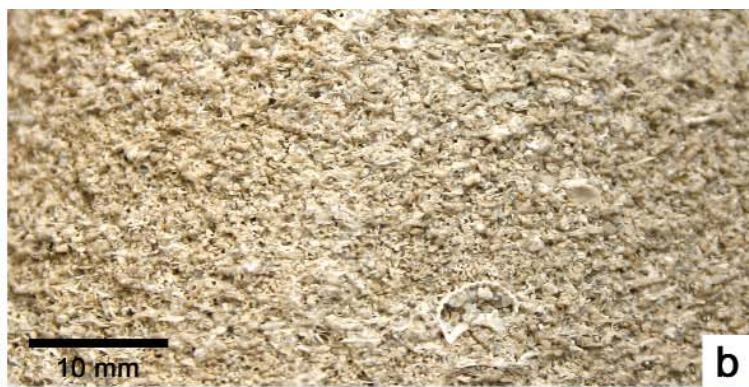
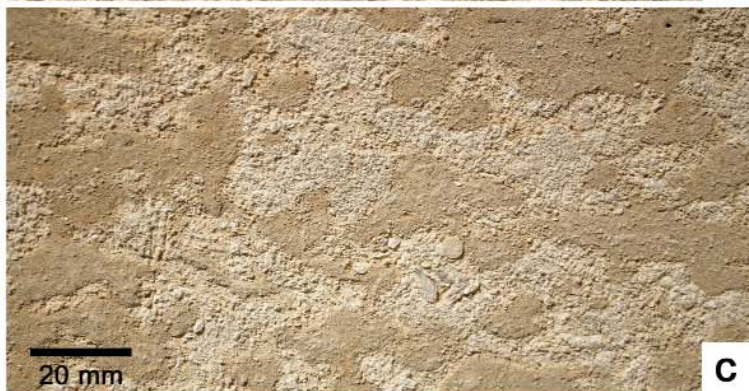
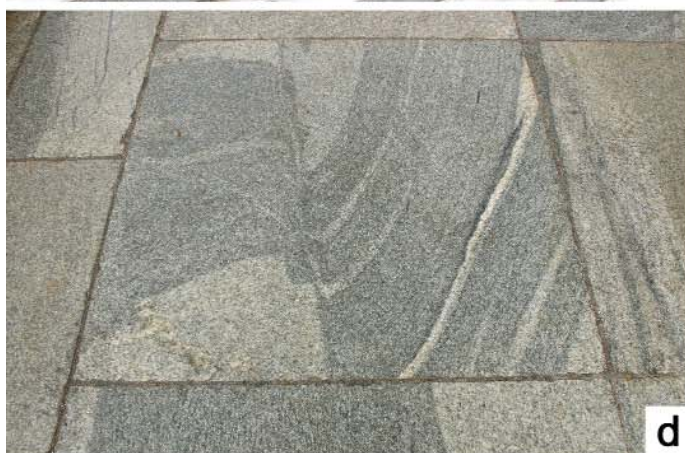
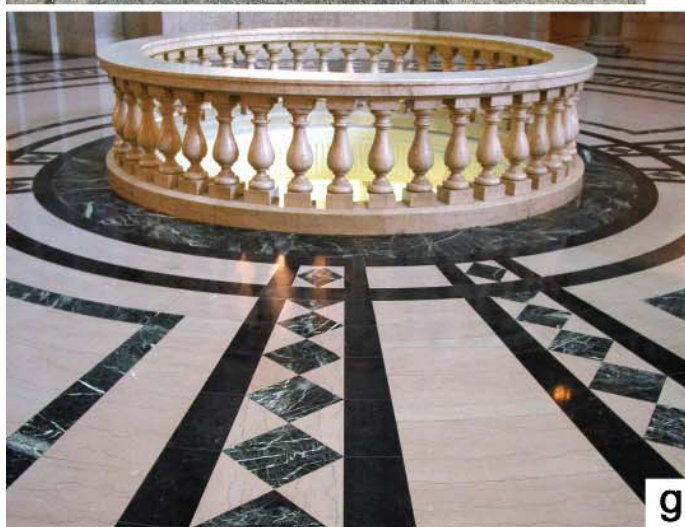
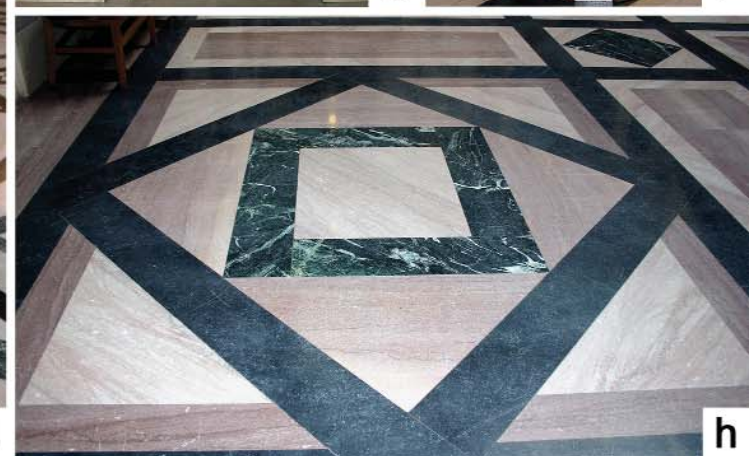
**Figure 7.** (*Opposite page*) Building stones and their usage in the Manitoba Legislative Building. 7a) Exterior view of east side of the building; walls and plinth are Tyndall Stone, statue is Bedford limestone, and steps are Butler granite. 7b) Bedford limestone of exterior statue showing weathering relief and details of ooid and fossil grains. 7c) Tyndall Stone; detail of exterior stone showing differential weathering between pale buff limestone and darker dolostone burrow mottles; note abundant crinoid grains, particularly in the limestone. 7d) Butler granite, gneissic type. Slab is 1.22 m wide. 7e) Tyndall Stone alcove, second level interior hallway. Tyndall Stone in the walls is oriented parallel to original bedding, except in the keystones of the arch where the stone has been rotated so that bedding is in a radial position; baseboards are of Botticino marble. 7f) Drinking fountain carved from pink-red Tennessee marble shows the characteristic layer-parallel stylolites; the floor is of Tennessee marble and Ordovician black marble, and the baseboard is Botticino marble. 7g) Decorative use of marbles in the rotunda at the top of the Grand Staircase. The carved balustrade encircling the opening to the Pool of the Black Star is Botticino marble; the floor includes grey-pink Tennessee marble, Ordovician black marble, and green Vermont Verde Antique marble. 7h) Marble floor on the main level of the Grand Staircase Hall is composed of pink and grey-pink shades of Tennessee marble, Ordovician black marble, and green Vermont Verde Antique marble.

The mottles that give Tyndall Stone its characteristic appearance (Fig. 7c) are generally considered to be burrows made by organisms moving through the muds of a soft ancient seafloor (Kendall, 1977). The large burrows that form the mottles are assigned to the ichnogenus *Thalassinoides*; these were probably produced by arthropods (Kendall, 1977; Coniglio, 1999). Within these large burrows can be seen smaller burrows that have distinct outlines. These were made by organisms, possibly polychaete worms, which mined the original burrow fills for nutrients (Kendall, 1977).

The Tennessee marble is characterized by well developed stylolites having two orientations. Those parallel to bedding planes are predominant and those oblique to bedding are less common. The stylolites parallel to bedding are well demonstrated in three dimen-

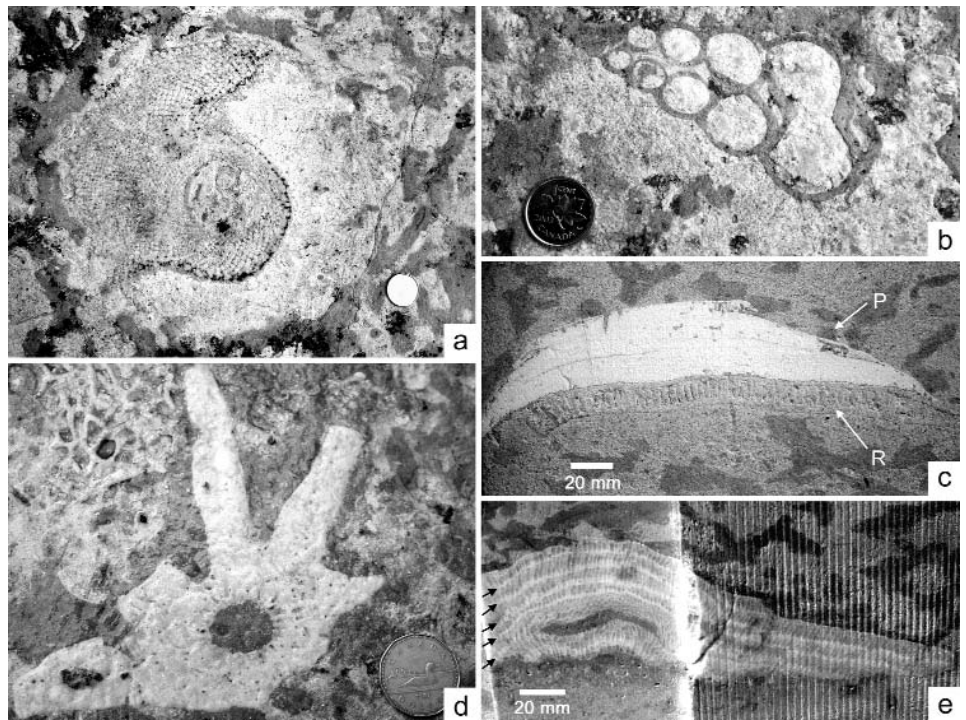
**Figure 9.** Examples of the diverse fossils in Tyndall Stone at the Manitoba Legislative building; a to d are on exterior surfaces; e is at the top of the Grand Staircase. 9a) Receptaculitid *Fisberites*, transverse section; coin diameter is 19 mm. 9b) High-spired gastropod (snail); coin diameter is 19 mm. 9c) Vertical section of receptaculitid (R) encrusted by tabulate coral *Protrochiscolithus* (P). 9d) Sponge (lower centre), with the chain tabulate coral *Manipora* (upper left); coin diameter is 26 mm. 9e) Vertical section through colony of the rugose coral *Crenulites*, showing distinct cyclic banding that probably represents annual growth bands (arrowed).

The most common Tyndall Stone macrofossils are receptaculitids, an extinct group of uncertain affinities, possibly calcareous green algae (Wong, 2002; Figs. 9a, c). The second most abundant group is the solitary rugose corals (horn corals). Other common fossils include stromatoporoid sponges, colonial rugose and tabulate corals, bra-

chiopods, bryozoans, gastropods, cephalopods, and trilobites (Figs. 9b-e). The most abundant bioclasts in Tyndall Stone are sections of echinoderms. These can be readily observed on the outside of the Legislative Building, where grains are more visible as a result of weathering (Fig. 7c). Complete echinoderms are very rare because their skeletons were readily broken up after death.

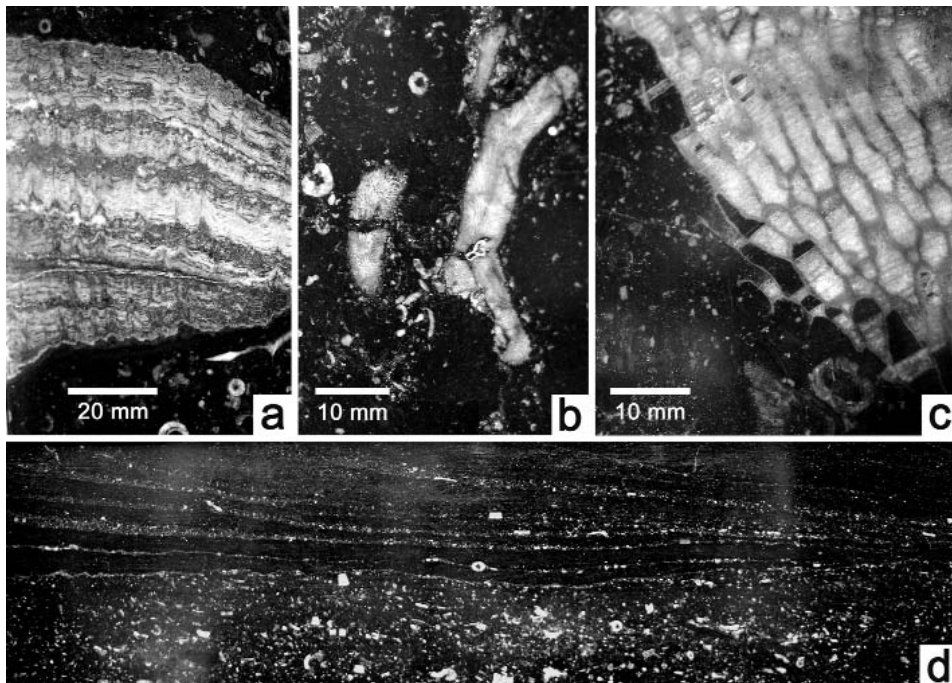
**Figure 10.** Examples of fossils and structures in Ordovician black marble in the Legislative Chamber. 10a) Stromatoporoid sponge, vertical section. 10b) Branching bryozoans associated with echinoderm debris. 10c) Colonial coral *Foerstephyllum* sp., oblique vertical section. 10d) Vertical section of cross-laminated limestone, with abundant echinoderm (crinoid) debris.

In the black marble, the most abundant fossils are crinoid stem segments, but there are also brachiopods, bryozoans, stromatoporoids, cephalopods, gastropods, and corals (Fig. 10a-d). These are similar to forms found in the Crown Point Formation and other Chazy units. The fossil assemblage includes stromatoporoids similar to the Crown Point Formation's *Labechia* and *Pachystylostroma* (Kapp and Stearn, 1975), and examples of the coral genus *Foerstephyllum* consistent with *F. wissleri* (Welby, 1961), which occurs in blue-black limestones of the Crown Point Formation in the Lake Champlain area. Nevertheless, we have not been able to identify the most characteristic Crown Point fossil, the gastropod *Maclurites magnus* (Oxley and Kay, 1959). Consequently the Legislative Building stone could have been derived from
