The Chancel of St. Paul's Anglican Church, Halifax, Nova Scotia: Form Follows Convenience?

J. Philip McAleer

McAleer, J. P. (1990). The Chancel of St. Paul's Anglican Church, Halifax, Nova Scotia: Form Follows Convenience? *RACAR : Revue d'art canadienne / Canadian Art Review*, 17(1), 46–53. <https://doi.org/10.7202/1073155ar>

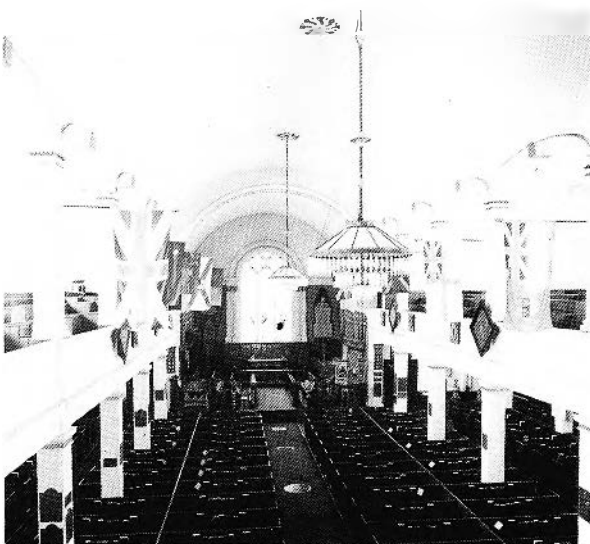
FIGURE 33. St. Paul's, Halifax. The interior as it appeared in 1987 (chancel of 1872) (Photo: T.U.N.S./P. Toman).

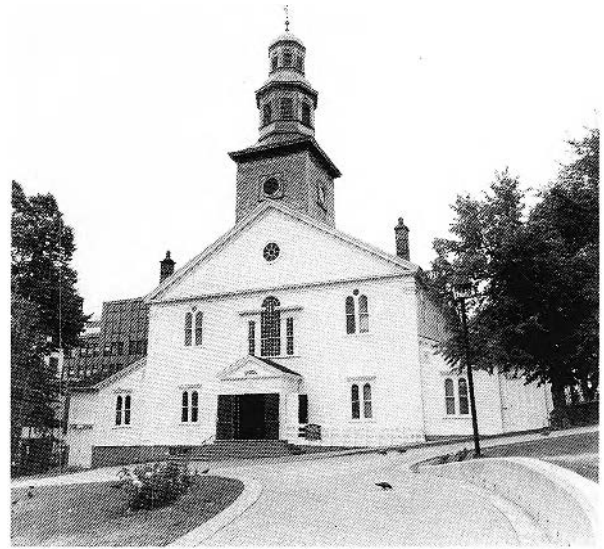
FIGURE 36. *St. Paul's*, Halifax. The (north) façade of 1812, as it appeared in 1987 (porch of the 1950s) (Photo: T.U.N.S./P. Toman).

During the century following its completion, St. Paul’s underwent only two significant alterations, both being expansions of the original rectangular box. An entrance vestibule containing new, more ample stairs to the galleries, and two rooms to be used as vestries were added at the north façade in

1812 (Fig. 36).¹⁶ In 1868, the church was enlarged again, this time laterally by the addition of an outer pair of aisles, the solution to a chronic shortage of pews (Fig. 37).¹⁷ Both of these additions were made for reasons of convenience. It is with some surprise that one notes there was no discussion about constructing a separate chancel during the 1840s, 1850s, or 1860s as a reflection of the ideas promulgated by the Ecclesiologists. Indeed, when a chancel was finally added in 1872, it too came as a result of concerns about “convenience,” and appears rather as an afterthought in the wake of the enlargement of 1868.

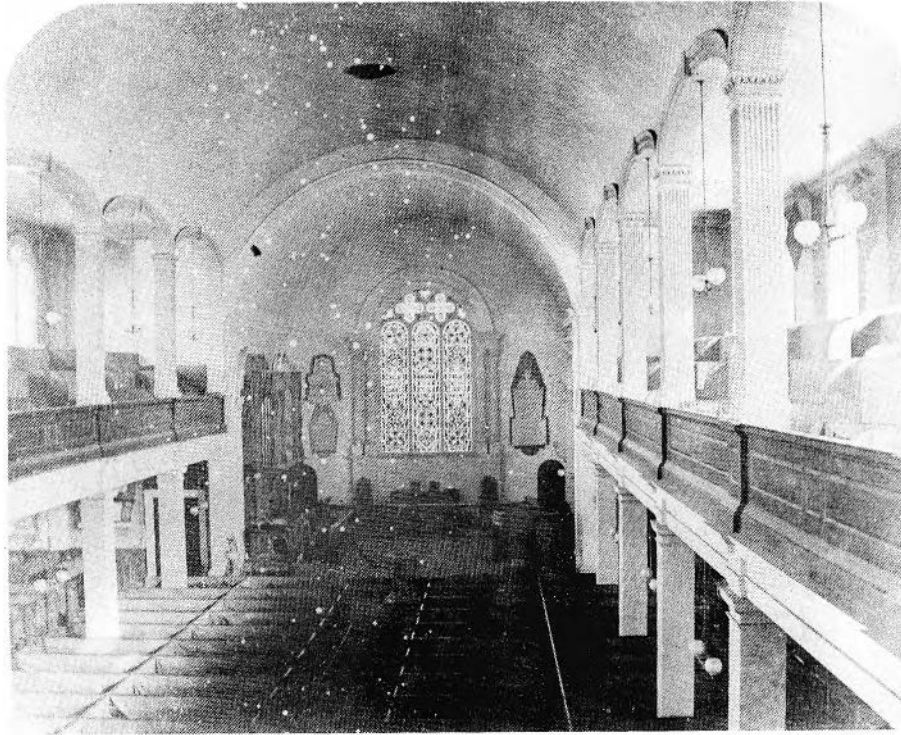
FIGURE 39. Anonymous, *St. Paul's*, photograph, ca. 1872-75. View to south after addition of the chancel in 1872.

The new chancel, 28 feet long, was squarish in plan with a barrel vault and an arch lower than the nave’s (Figs. 38-39). It was flanked by two narrow rooms or wings,²⁰ with the interior side walls of the chancel enlivened by two large blind arches with Corinthian pilasters. The south wall was domi-

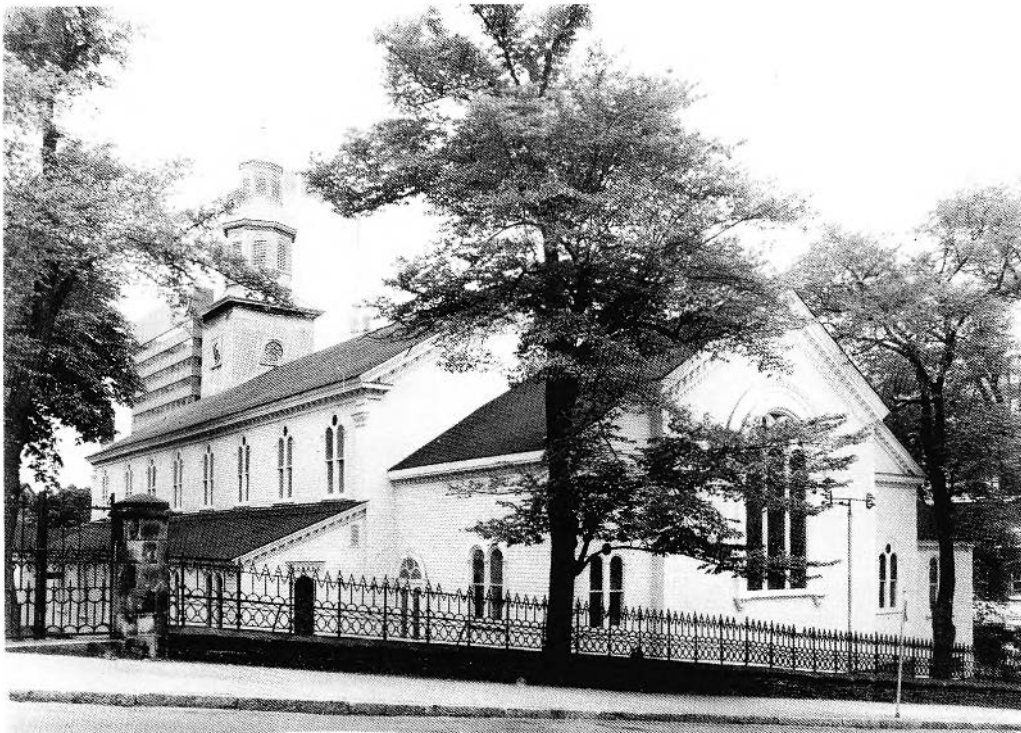
FIGURE 40. *St. Paul's*, Halifax. The chancel of 1872 (altered in 1908-1909), as it appeared in 1987 (Photo: T.U.N.S./P. Toman).

Considerations of practicality and convenience appear to have prevailed even as late as 1908-1909 when a new and larger organ was purchased, necessitating alterations to the side arches and rooms flanking the chancel. At that time, some discussion took place about the possibility of extending the chancel to the street line.³⁸ The reasons for wanting to do so are not made clear, but there was apparently a felt need once again for more room, perhaps to accommodate the pews for the choir. Eventually, the extension was not made

Yet in 1908, the “old” architecture which would have been destroyed was the south wall of the chancel erected only in 1872! Furthermore, by 1908 most of the exterior of the eighteenth-century building had disappeared—without protest at any time. Far more damage to the “old” architecture of the church than could be done in 1908 was done in 1868 when the outer aisles were added; in 1869, when the upper (gallery) windows were changed (to “match” the new lower ones); and in 1872, when the addition of the chancel eliminated the last vestige of the exterior of the original building of 1750.
