Geological Hazards and Disasters in St. John's

David Liverman, Norm Catto and Martin Batterson

Volume 21, Number 1, Spring 2006

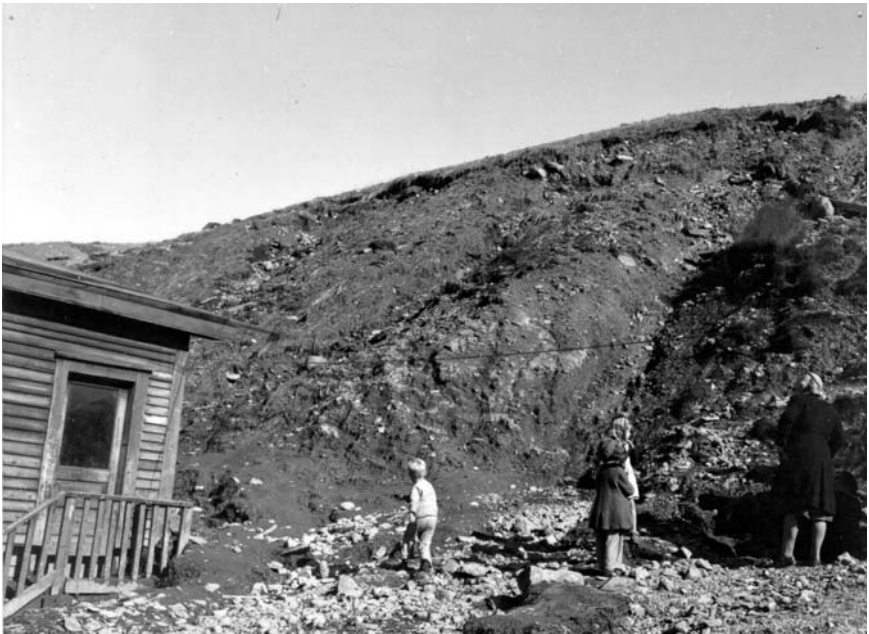
Figure 3. The scar left by the landslide of 15 September 1948 at 387 Southside Road (St. John's City Archives, used with permission).

Maureen Windsor (aged 3) was swept against the rear wall of the kitchen and apparently crushed against the chimney, being killed instantly. The landslide had, as in the 1936 disaster, broken through the rear wall of the house (Figure 3).

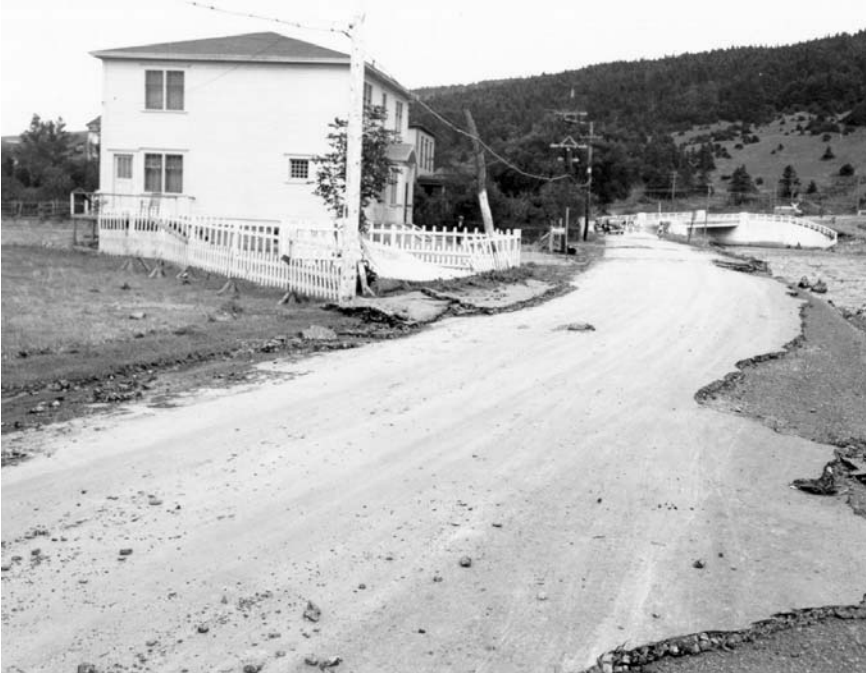
Figure 4. Flood damage on Southside Road, September 1948 (St. John's City Archives, used with permission).

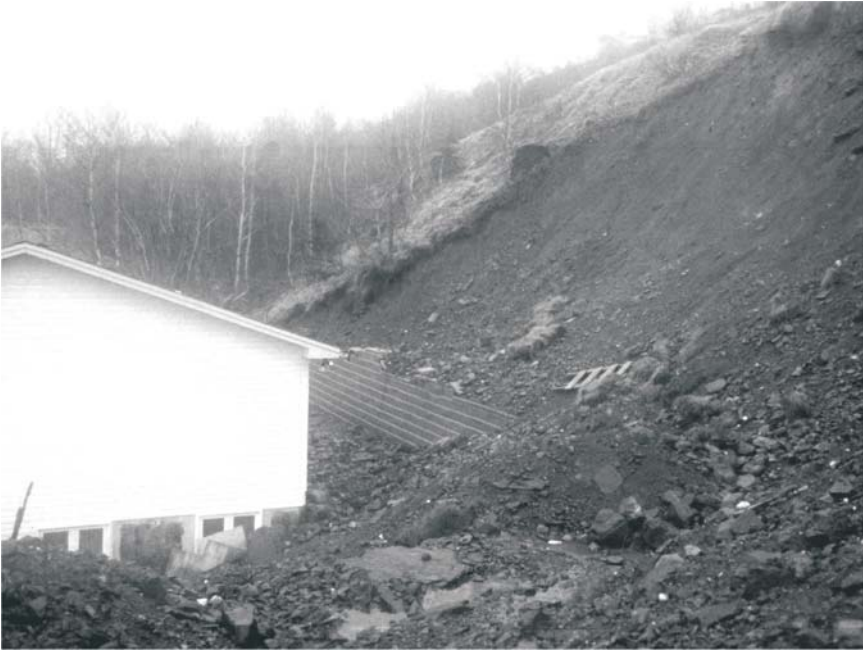
Figure 5. Recent construction on Southside Road, undercutting steep banks of till and increasing landslide hazard.

The slope stability and flooding problems no longer occur to the same extent, due to the construction of Pitts Memorial Drive in the early 1970s. This major highway is situated halfway up the slope, and much of the water that affected Southside Road is contained within ditches and culverts. Local residents state that flooding has not occurred for many years, although some difficulties persist along Symes Bridge Road. Slope stability, particularly rockfall, is still a problem on Pitts Memorial Drive after heavy rains and as a result of frost heaving. The road has been temporarily blocked completely or partially on several occasions since 1990. In spring 1996, a driver was injured when her vehicle hit rocks that had fallen into the road. Minor landslides have been observed on Southside Road after heavy rains. Currently, the City of St. John's, after consultation with the Newfoundland and Labrador Geological Survey, requires a geotechnical evaluation of slopes for any new construction in this area (Figure 5).

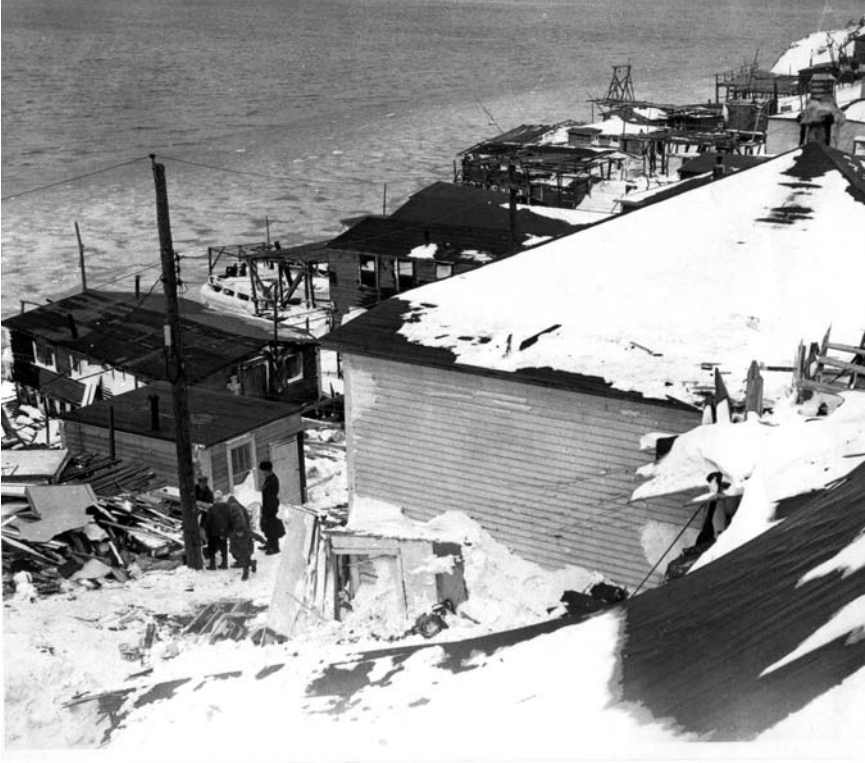
Figure 6. Aftermath of the 1959 Battery avalanche (from the collection of Shirley Eales, used with permission).

There are no records of further avalanches until 1959, when the worst geological disaster in St. John's history occurred. A ferocious storm hit St. John's on the night of 16 February, with winds reported up to 200 kilometres/hour, and depositing 55 centimetres (22 inches) of snow. At 1:05 a.m., residents in the Outer Battery heard a sound described as being louder than a clap of thunder. An avalanche struck two houses belonging to the families of Clarence Wells and Jim Piercey, sweeping them downslope and into the rear of two other houses. The houses contained 14 people who were all swept downslope and buried. Clarence Wells was the nephew of Alfred Wells, whose family was hit by the 1921 avalanche. The top storey of the Piercey house was ripped off, and the Wells house demolished (Figure 6).

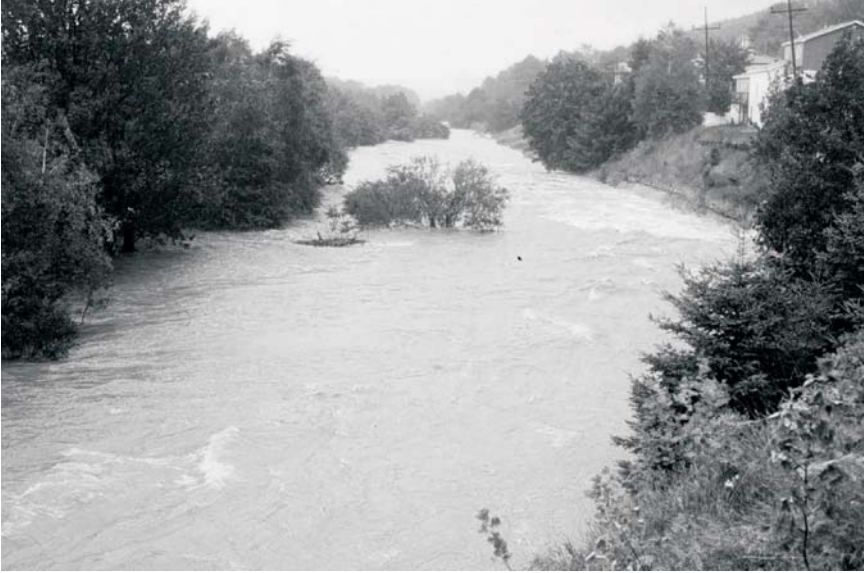
Figure 8a. The Waterford River in full flood, 19 September 2001.

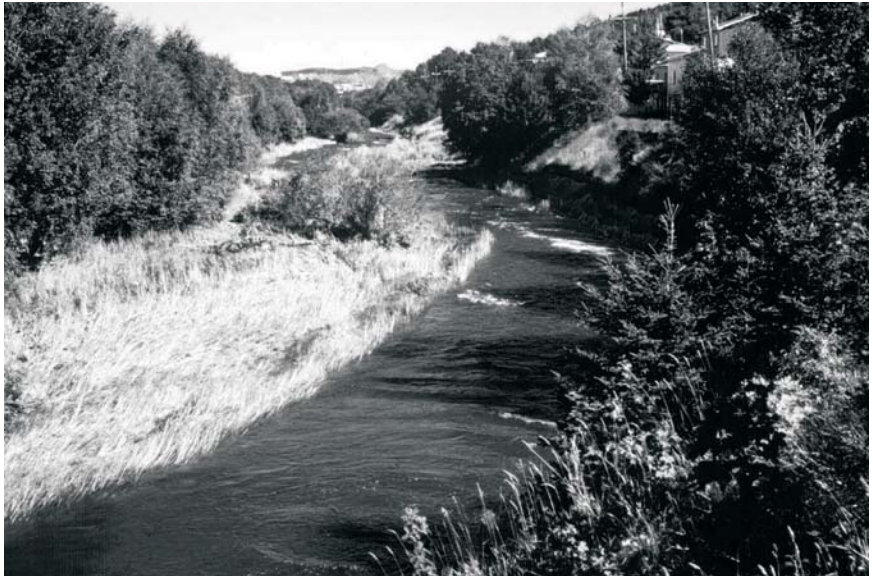
Figure 8b. Waterford River 24 hours later, showing effect of flood, and rapid return to normal water levels.

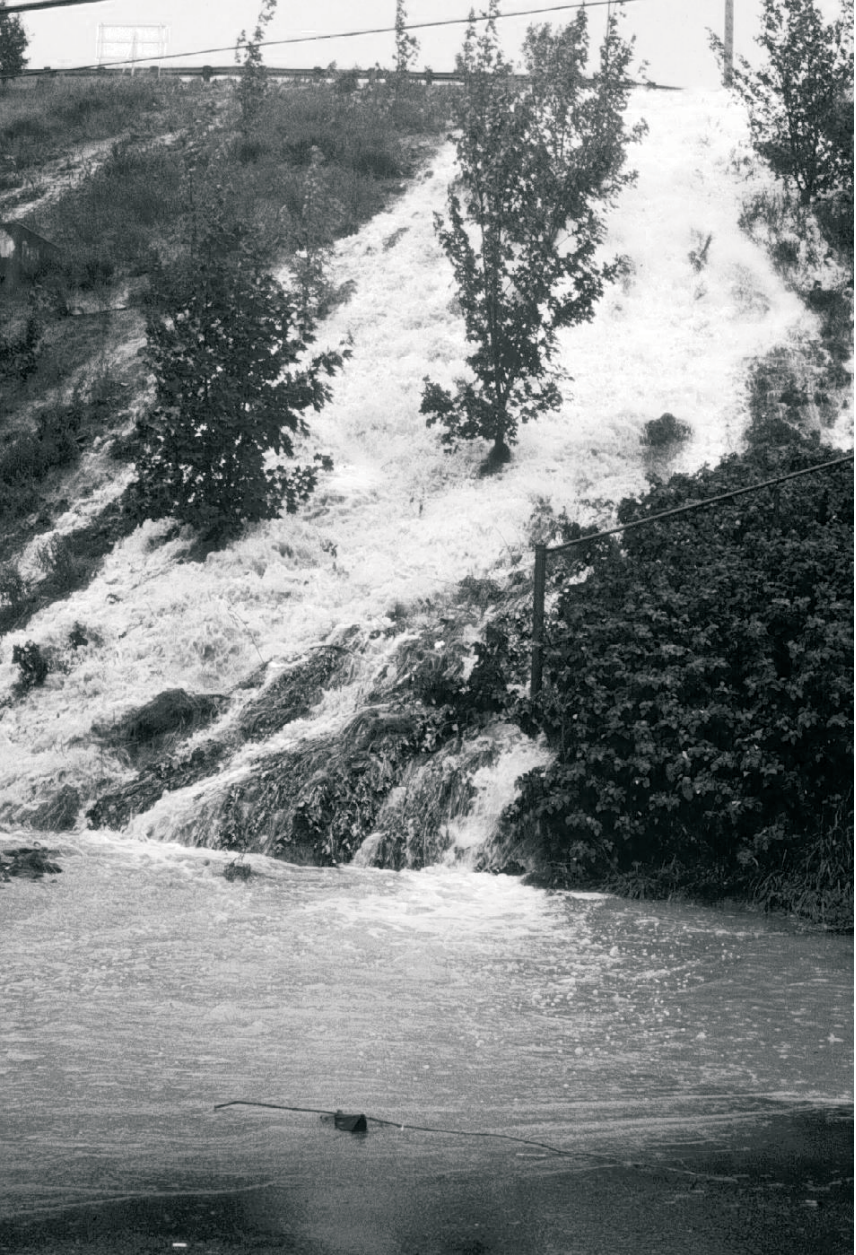
Figure 9. Waterfall created on Southside Road during September 2001 floods.

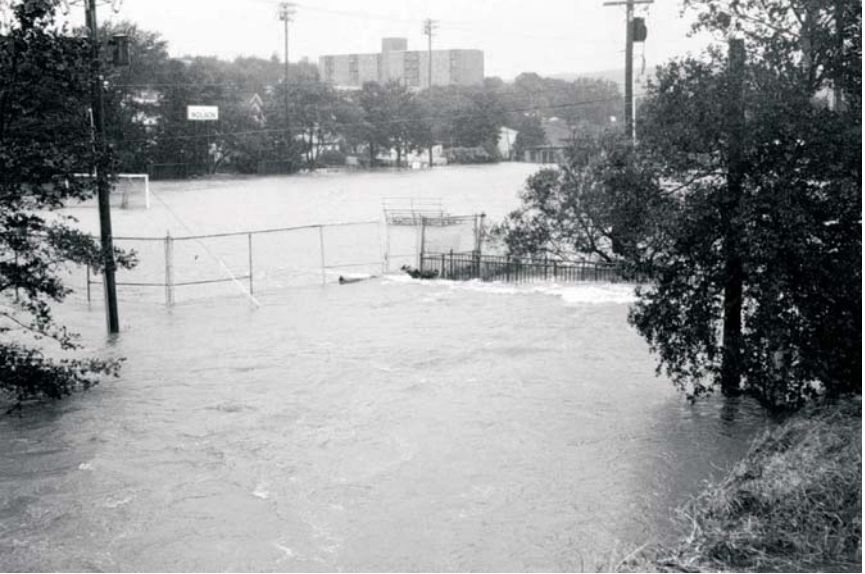
Figure 10. Floods cover soccer field at head of Quidi Vidi Lake, September 2001. Note footbridge over Rennie's River forming dam as it blocks flood waters.

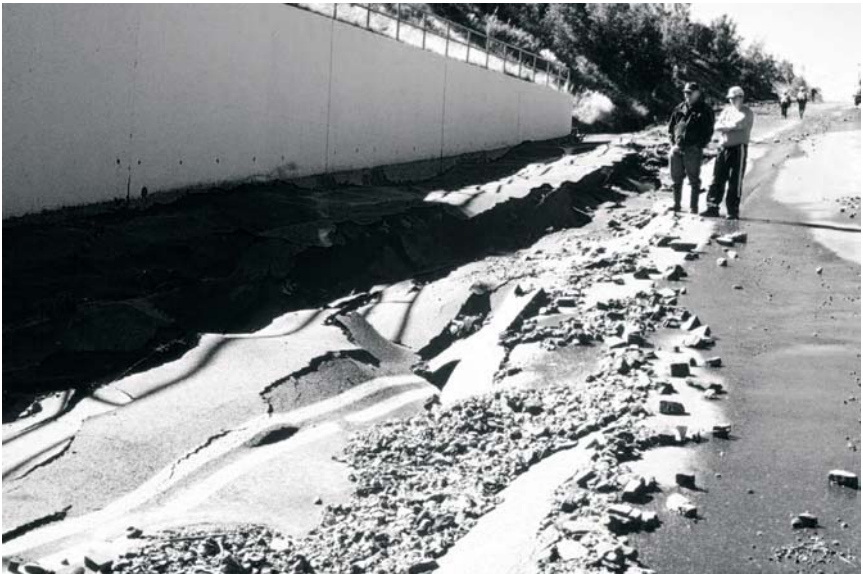
Figure 11. Flood damage on Shea Heights road, September 2001.

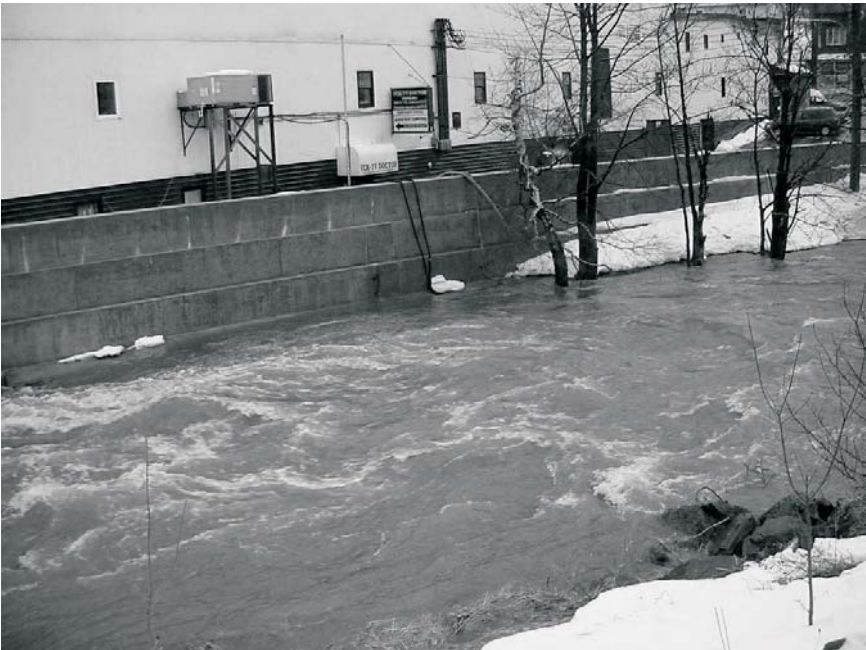
Figure 12. Flood protection, Waterford River, constructed after 2001 flood.

sional flooding. Thus by the 1940s, the area around Quidi Vidi Lake, previously mostly agricultural land, is often mentioned as being flooded, with houses damaged. By the 1960s, the Churchill Park-University Avenue-Avalon Mall area has been added to the area vulnerable to floods, and, by the 1980s, expansion of the city adjacent to the Virginia River, along Leary's Brook, and in the Goulds, meant that these areas were also vulnerable to flooding (Figure 12).
