The Lesson of the Quebec Bridge

Wilfred G. Lockett

THE LESSON OF THE QUEBEC BRIDGE

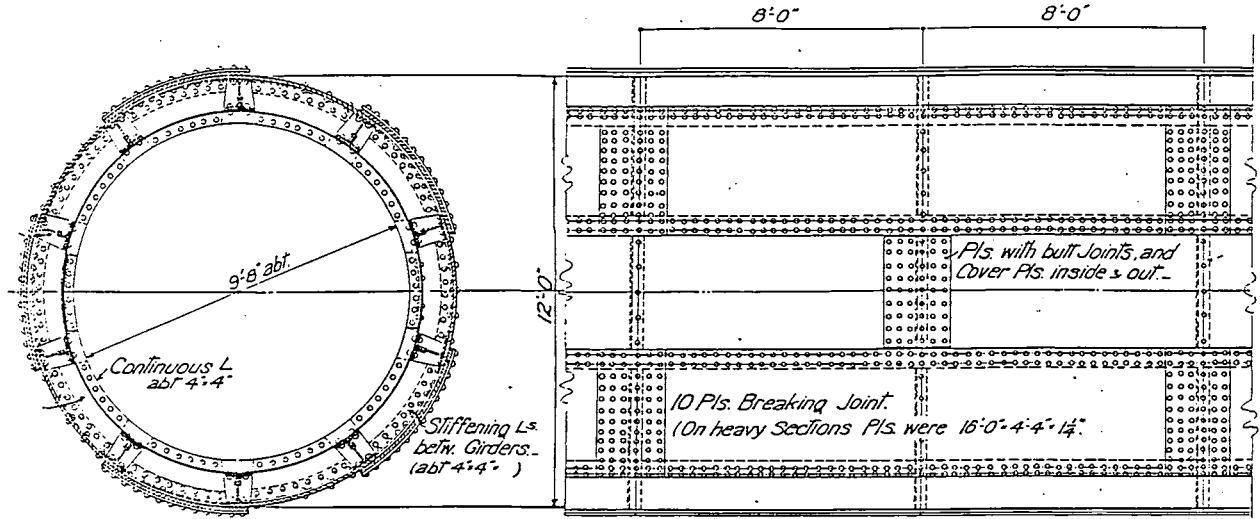
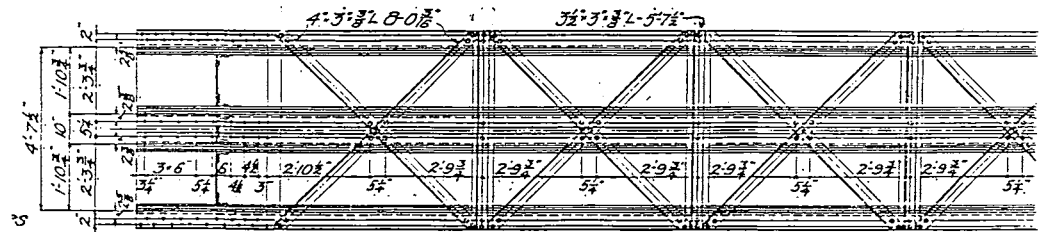
FIGURE 5

(a) FORTH BRIDGE COMPRESSION MEMBER - SECTION AND ELEVATION

SECTION

PLAN ON A-A

(b) QUEBEC BRIDGE COMPRESSION MEMBER

We have now to consider the design of the compression members and in particular those of the lower chord, that part of the cantilever incorporating the distinct curve shown in Figure 2(b). As noted above, the strength of a compression member or strut depends principally on its resistance to buckling. In the case of the Forth bridge this was neatly accomplished by giving the members a cylindrical form, which during the erection stage involved the building up of the member curved plate by curved plate, a procedure well suited to the skills of Scottish shipwrights. But in North America the accepted practice was to use standard rolled steel sections (angles, flats, I-beams, etc.) in the fabrication of structural members. In the Quebec bridge the struts were built up from an array of parallel flat plates. Figure 5 shows a comparison of the compression members of the Forth and Quebec bridges. The bracing introduced for stiffening the latter may be clearly seen. The active cross-sectional area was about 800 square inches in Forth bridge and 842 square inches in the Quebec bridge.
